**Resourcing
Solutions**
engaging people

HSQE Briefing
August 2019

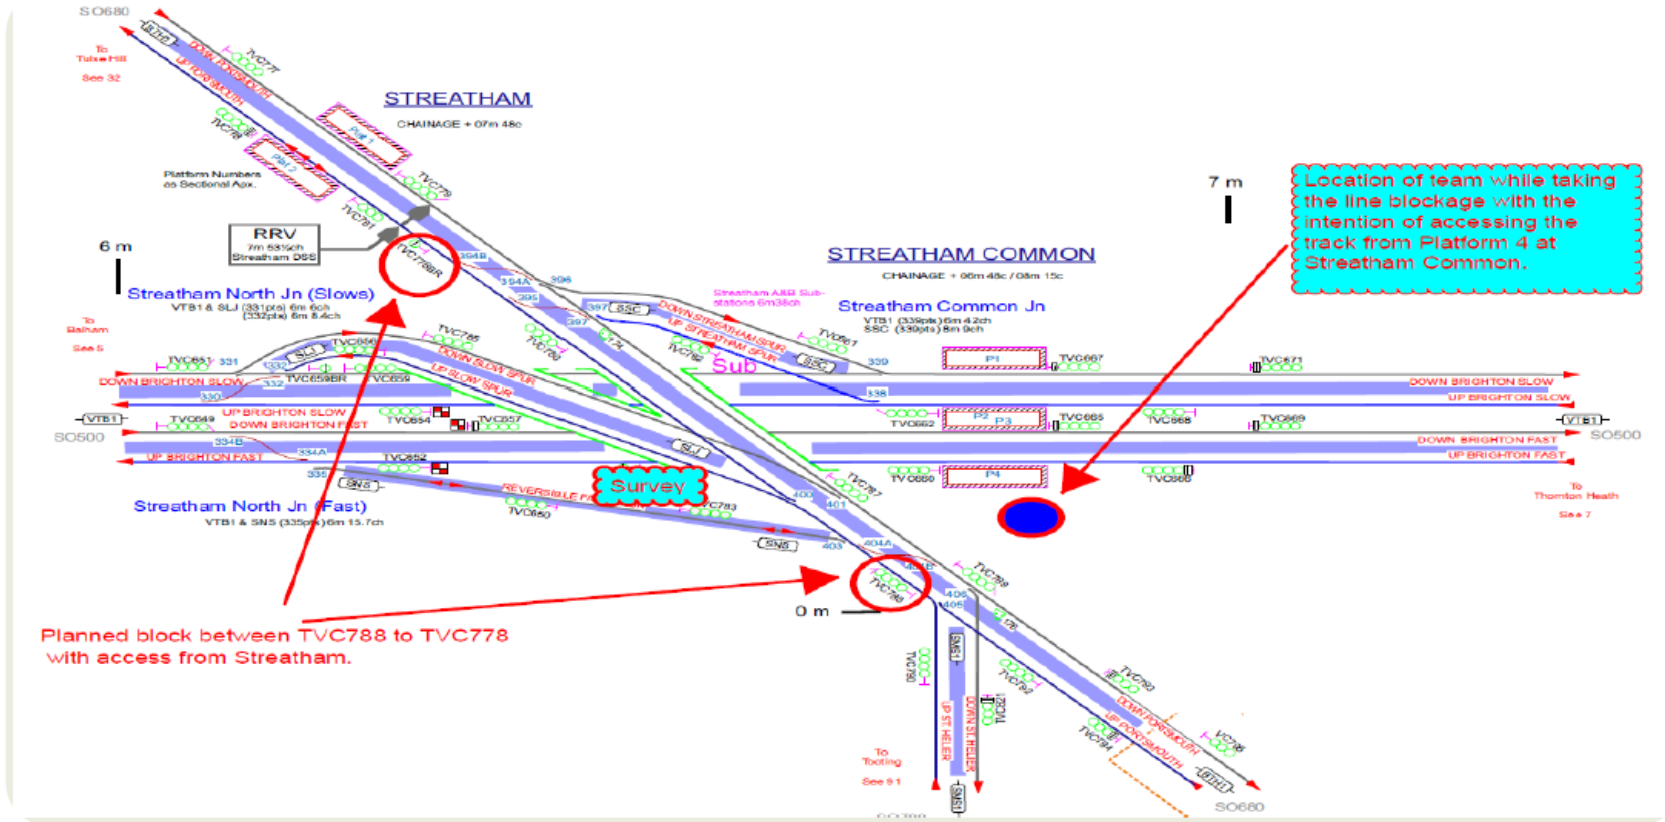
The SWL/COSS arrived at Streatham Common station car park and contacted the Signaller to discuss the line block arrangements to access an area for FTN Node survey within a REB on the BTH1 line.

During the conversation between a Signaller and a COSS/SWL to arrange a line blockage it became apparent, due to the vigilance of the signaller, that the COSS was potentially going to access at the wrong location meaning the team would not have adequate protection in place.

The planned line block covered access from **Streatham** along the **BTH1** line between TVSC778 and TVSC788.

The COSS was potentially going to access from **Streatham Common** which is on the **VTB1** line, with the planned line blocks between TVSC778 and TVSC788 signals on the Up Portsmouth line. The operative stated that he was speaking from Streatham Common station (VTB1 line) and identified the location of the worksite. The Signaller challenged the COSS/SWL regarding the worksite location for access and cancelled the proposed line blockage.

- Are Safe Work Packs comprehensively reviewed and authorised by the Responsible Manager before being issued?
- Are Safe Work Packs reviewed prepared and by the COSS/SWL prior to the start of work and on arrival at the access point?
- Do we allow ourselves to become complacent when working in familiar locations?
- Could we use technology to check our location?
- Do we regularly challenge and question current processes?

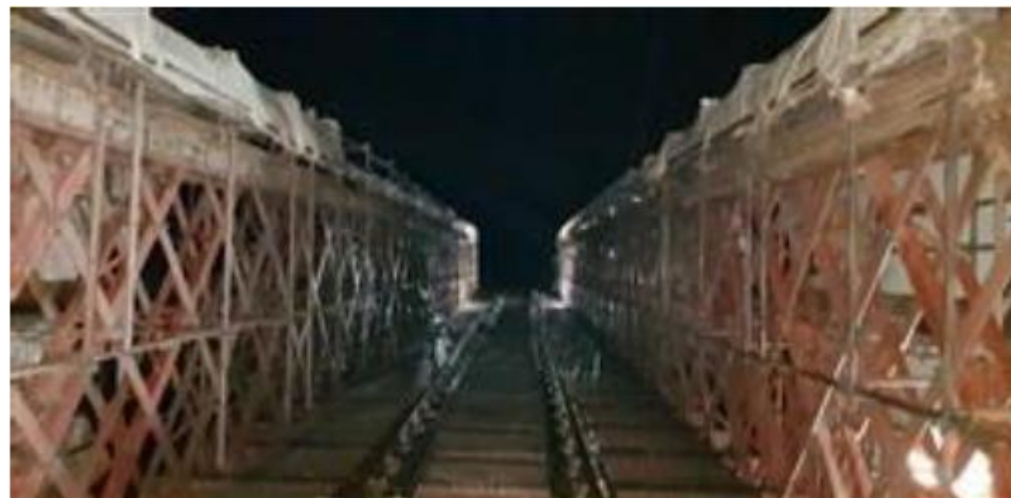
Whilst walking at night along a mesh-grid walkway on the bridge at track level, the Injured Person (IP) fell forwards and through a void. The IP fell approximately 1.5 metres down onto the scaffold deck below and sustained bruising to the side of his body.

Walkway panels had been removed to allow workers to pass materials up from the scaffold deck below. However, the IP was unaware of this. The IP attended hospital and had to take time off work to recover from his injuries.

- A change in work activity occurred.
- The change was neither adequately planned nor risk assessed.
- The Task Briefing Sheet did not reflect the works or arrangements required.
- Suitable controls to address the hazard were not implemented or discussed before or after removing the walkway panels.
- Lighting at the site of works was inadequate.

- Works **MUST** be planned, and risk assessed to avoid late change in the first instance.
- Works **MUST** be re-assessed if late change is required to manage risk effectively.
- Who is responsible for controlling activity on site and ensuring effective communication of hazards and related risks?
- How do you ensure adequate resources are provided on site, particularly in remote locations?

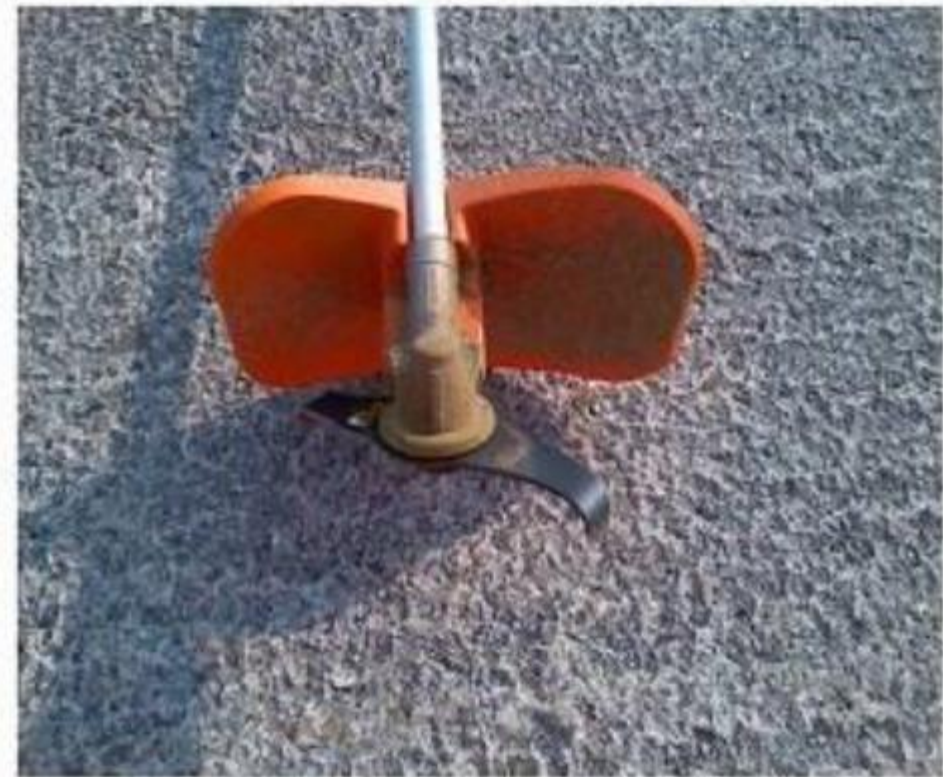
Figure 1 - Stihl brush cutter with shredder blade and correct protective guard fitted.

On 2 July 2016, an operative was using a metal star blade for brush cutting at the Newgate Street access point. This resulted in a piece of metal shard piercing the inner right thigh of the operator. A safety bulletin was subsequently issued (NRB 16/13), and a root cause investigation launched.

Both incidents involved a metal object hidden in the undergrowth being struck and a shard of metal being ejected.

Metal star blades must be replaced with OEM approved 'Shredder' blades for brush cutting operations. Metal star blades must never be used for brush cutting.

- The tool and equipment supplier/maintainer must ensure that the brush cutter protective guard is undamaged/untampered and correctly fitted (See Figure 1). Brush cutters with defective blades must be quarantined until repaired.
- All operators carrying out de-vegetation works must possess the required level of training and competency.
- Use of brush cutters for de-vegetation must be considered during the task planning process as a "right handed" operation which offers the optimum protection to the operator.

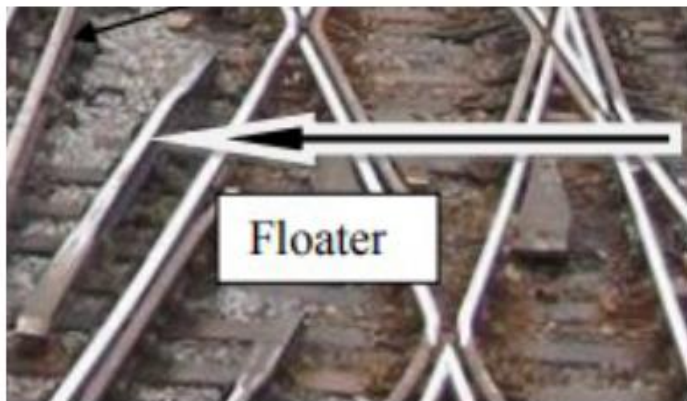
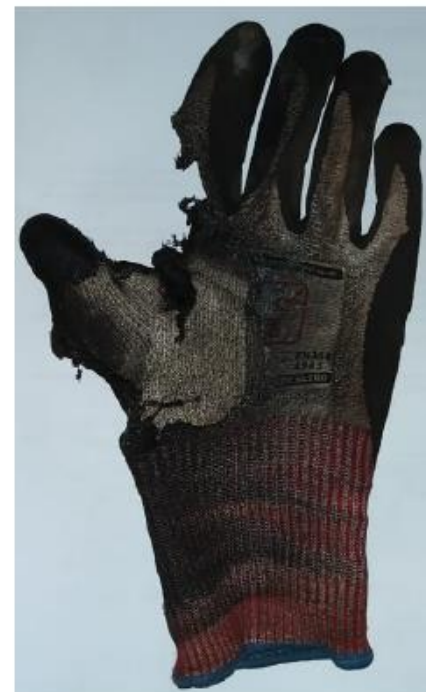
A serious safety incident occurred last night when a colleague setting up site lighting came in to contact with the live conductor rail. The live rail was a floater believed to have been isolated (example of a floater above)*.

The IP suffered severe burns to their hands. However, this could have been a lot worse but the IP was wearing flame retardant PPE and gloves at the time.

Floaters are short lengths of conductor rail that can abut or infringe an isolation and can remain live because they are fed from an adjacent live conductor rail in a different electrical section.

- Always assume that the third rail is live and test before touch
- Are you aware of live floaters in your worksites?
- Always wear the correct PPE for the task
- Are you indicating live floaters on site using devices such as self-testing con rail indicator devices?
