# HSQE Briefing February 2019

- It has been a very busy month for Network Rail bulletins so please take the time to read and understand all of these briefings;
  - RIDDOR (Burned by hedge trimmer)
  - OTP exclusion zone lighting
  - Person struck by OLE
  - Near miss - Group of workers almost hit by a train
  - Long portable earths used in OLE Isolations
  - Control of mini diggers using digital comms

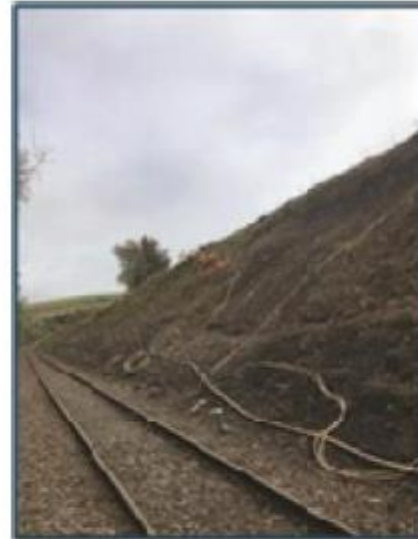
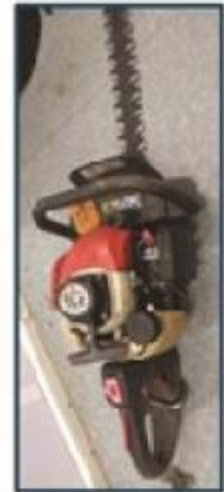
A petrol driven hedge trimmer was being used to cut light brush. After 3-4 minutes the equipment was placed on the embankment where it ignited.

The flames spread to the operative's right leg causing a significant burn.

The investigation revealed that fuel leaked from the hedge trimmer whilst in use. There was no visible damage to the equipment but, the fuel cap was found 2-3 metres away.

- The injured person had not been trained to operate the equipment
- The fuel cap was not attached / correctly attached to the hedge trimmer
- The IP had been permitted to use the hedge trimmer previously at site under supervision
- The lifesaving rule breach went unchallenged by both supervisors and workers on site

Never undertake any job unless you have been trained and assessed as competent

**Regardless of your role, be prepared to challenge Life Saving Rule breaches**

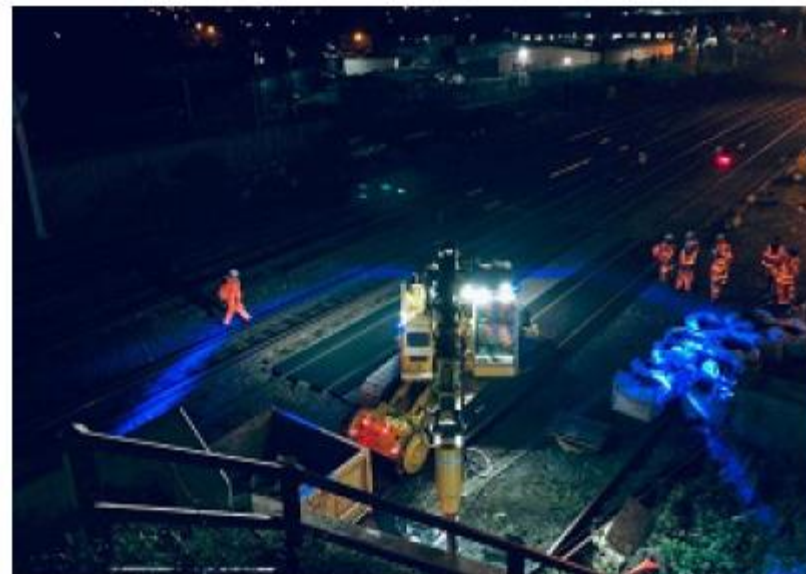
Recently, there have been many articles relating to lighting systems fitted to On Track Plant. These lights are blue lamps projecting beam patterns to depict exclusion zones on the ground. These systems have not been reviewed through the Product Approval process, and therefore should not be used.

The fitment of blue lights for this purpose, particularly to OTP Excavator Cranes, has a high potential to be confused with the requirements of RIS-1530-PLT Issue 6 Clause 9.7.2.1 'there shall be a continuous blue light fitted externally to the machine, visible to site personnel under all foreseeable lighting conditions and illuminated when the RCI is in lifting mode'.

Extra blue lamps fitted to the exterior of a cab or superstructure could mask an event where the RCI was disengaged. This is quite pertinent as there have been several recent events where OTP has overturned due to the RCI being set in the wrong configuration.

As with other Proximity Warning systems these systems require Product Acceptance to permit the use on Network Rail Managed Infrastructure. Network Rail strongly support developing innovations such as this when managed correctly.

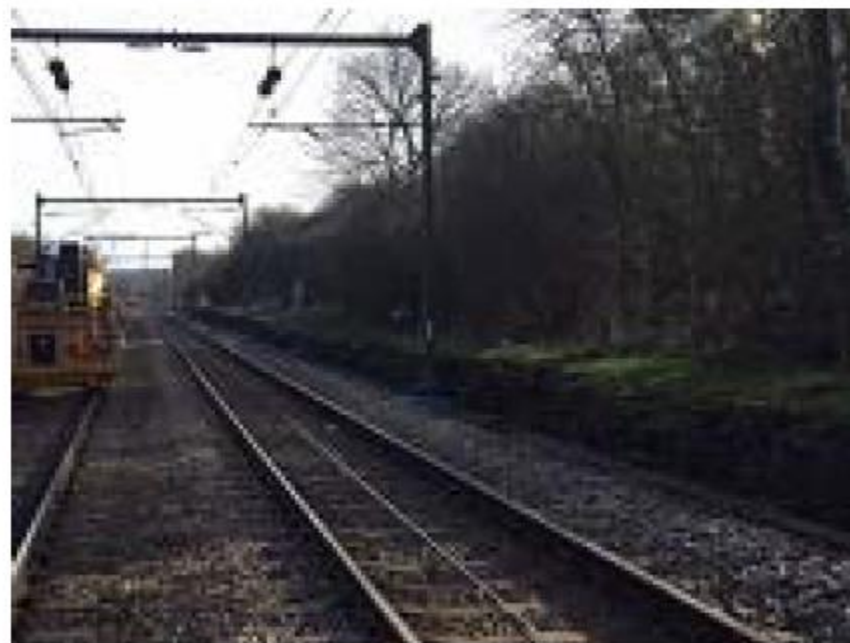
As the work progressed, some of the supporting temporary materials failed which resulted in the contact wire dropping to the ground uncontrollably, striking the injured person on the head and shoulders.

The injured person was wearing his hard hat, which took most of the impact, however he had pains to his back and forearm and was taken to the local hospital by ambulance for a check-up. The injured person was later released and is currently recovering at home.

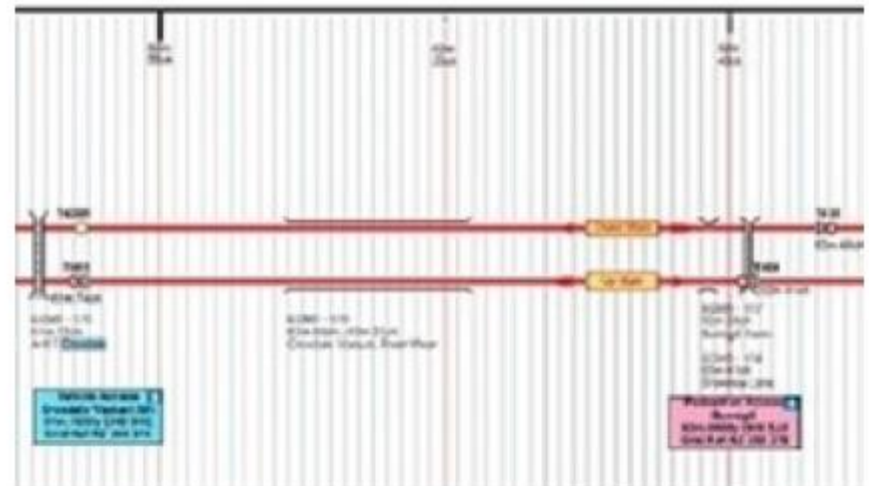
At 23:45 on the 20th January 2019, the driver of 5T83 made an emergency GSM-R call to report striking a worksite marker board on the Up Main at Croxdale Viaduct, and a subsequent near miss with two workers who had jumped clear of the train with just five seconds to spare.

The work group were monitoring the track associated with overhead line works and were working at the planned and agreed worksite location. But it was linked in error during planning to an unrelated possession at the same mileage on a different ELR some 90 miles away. This meant the worksite was on an open line, with a 90mph linespeed and no possession protection.

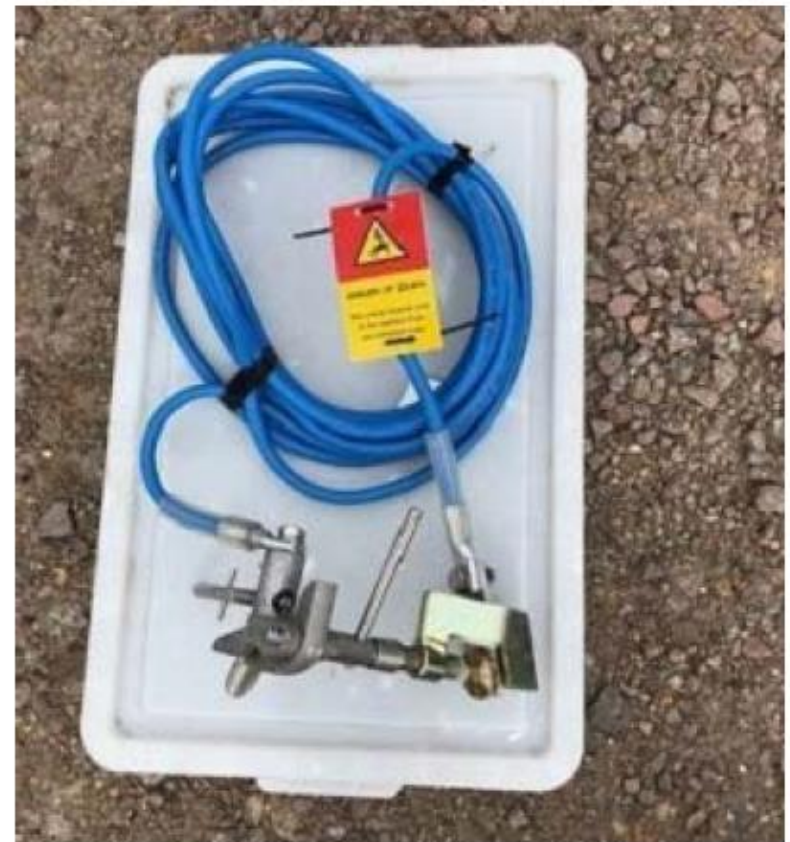
Following an isolation audit, it has become apparent that the industry is continuing to use the non-interlocked variant of long portable earths for earthing overhead line equipment.

At Ranskill in 1998 a member of the isolation team received a fatal electric shock when removing a non-interlocked long portable earth.

Investigation revealed the incident involved the failure to follow procedures detailed in Network Rail standard NR/L3/ELP/29987.

- Long portable earths shall only be used to earth isolated overhead line equipment when justified in accordance with NR/L3/ELP/29987.
- Non-interlocked long portable earths must not be used for earthing overhead line equipment after 01/03/2019. Only Product Approved interlocked long portable earths with warning labels at the G Clamp end shall be used for this purpose.

- a. When applying long portable earths, the earth connection shall be made before the line end is connected to the overhead line equipment
  - b. When removing long portable earths, the overhead line connection shall always be removed before the earth end is broken.

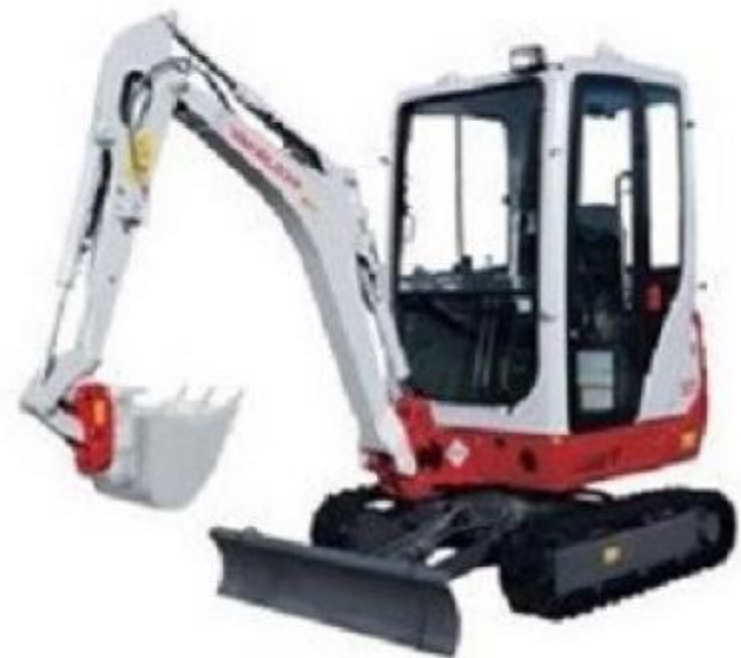
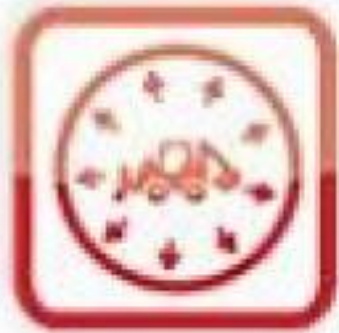
On 8th April 2018 a 1.6 Tonne mini-digger overturned at a site near Euston station. As it overturned it almost struck the banksman, who was standing next to the machine while it was setting up ready to dig.

The digger operator was in the process of extending the crawling tracks to increase stability by raising the machine using the rear blade and boom.

While in the raised position the operator accidentally moved the slew lever causing the machine to tip over.

The method of work used did not include the use of radio communications. As a result the banksman had to approach the machine to talk with the operator.

Never enter the agreed exclusion zone,  
unless directed to by the person in charge.

Whenever On Track Plant (OTP), On Track Machines (OTM) or non-rail mounted plant is used on Network Rail construction sites (rail or civils) full digital duplex communications are to be provided (by the Principal Contractor) and used.

All construction staff are to be made aware of the importance of maintaining an exclusion zone around all plant and the relevant Life Saving Rule because of dangers of inadvertent plant movement.
