## Lydney: Catastrophic Failure of Jacking Point on VMS Light Weight Signal Structure

# Lifting Operation: Failure to Secure Loads.

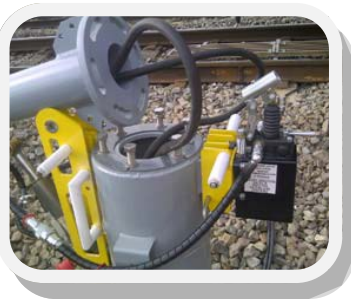
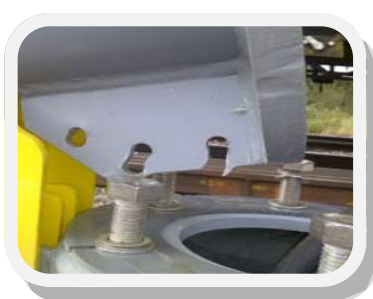
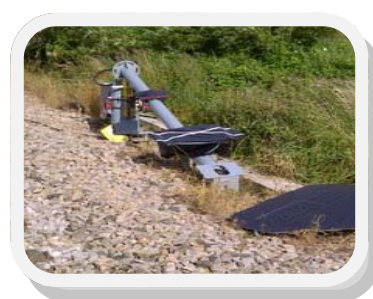
On 19<sup>th</sup> August 2012, a jacking point on a Variable Message Signs (VMS) Light Weight Signal catastrophically failed whilst being lowered to the ground. The light weight signal (NT1419) was being lowered during pre-commissioning works. No-one was injured as a result of this failure.

The cause of the failure is subject to investigation.

When the VMS Light Weight Signal is in its upright position it presents no risk, as there are no forces being applied at the jacking point.

☑ Until such time as the investigation has concluded and the cause of the failure established, the use of the jack system is to be prohibited.

☑ If work is required to take place on VMS Light Weight signal structures, an alternative system of work is to be established.

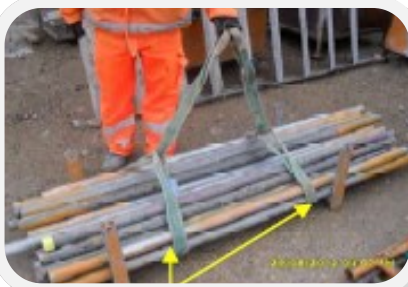
An incident occurred on 23rd August 2012 when an individual working on site was struck on their hard hat by a scaffold storage frame, sometimes referred to as a stillage, when it became detached from a load whilst being lifted. The frame formed part of a load that consisted of a number of 5ft scaffold tubes. As it was being lifted the load struck part of the scaffold it was being lifted onto, resulting in one part of the storage frame becoming detached from the load. The frame fell approximately 20ft striking the individual with a glancing blow on his hard hat. The individual suffered no serious injury.

Load was secured with straps in between It was believed that the frame did not need to be se-

Weight of scaffold tubes secures frame during lift

2 unconnected scaffold storage frames to the load via the strop as it was held in place by the

The investigation established that it was practice (both on this and other Thameslink sites) to lift with the storage frames unsecured to the load. The diagram above right indicates how the frame remains stable under normal conditions, despite being unsecured. Subsequent enquires with both the onsite scaffold company and the supplier of the storage frame/stillage have clarified that this is not the correct methodology for lifting of this equipment, however this had not been documented prior to the incident, and the investigation indicates that this had not been effectively communicated to the operatives on this site (and it would seem to other sites also).

Those employees and contractors whose work activity involves planning or undertaking lifting activities involving scaffold tubes and storage frames, or related lifting brackets, on Network Rail sites are to review lifting activities involving this equipment to check that all component parts of the overall load are properly se-

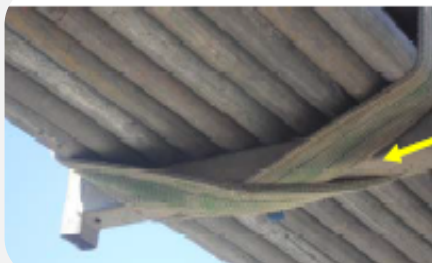
The frames at the site in question now employ a 'figure of 8' slinging technique around the frame/stillage and the tubes.

This means that the stillage is tied in to the overall load and cannot become detached in the event of an impact – which should be the case for all lifts
