Infrastructure Projects Signalling - Shared Learning

18/02: March 2018 – December 2018

This Shared Learning document details key issues and incidents that have occurred on Signalling Projects between March 2018 and December 2018 and provides the key learning points associated with them.

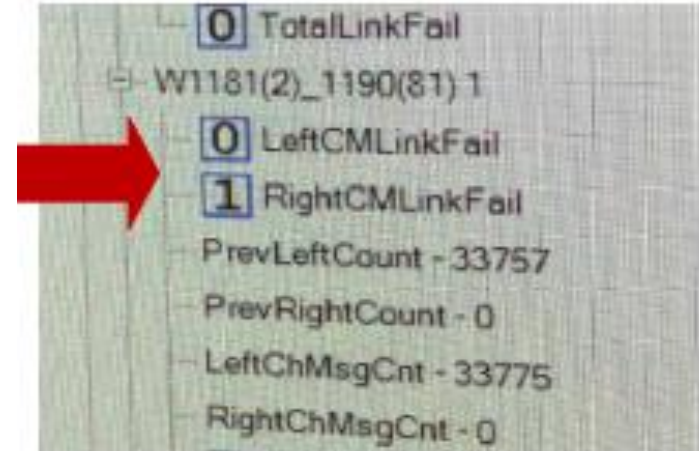
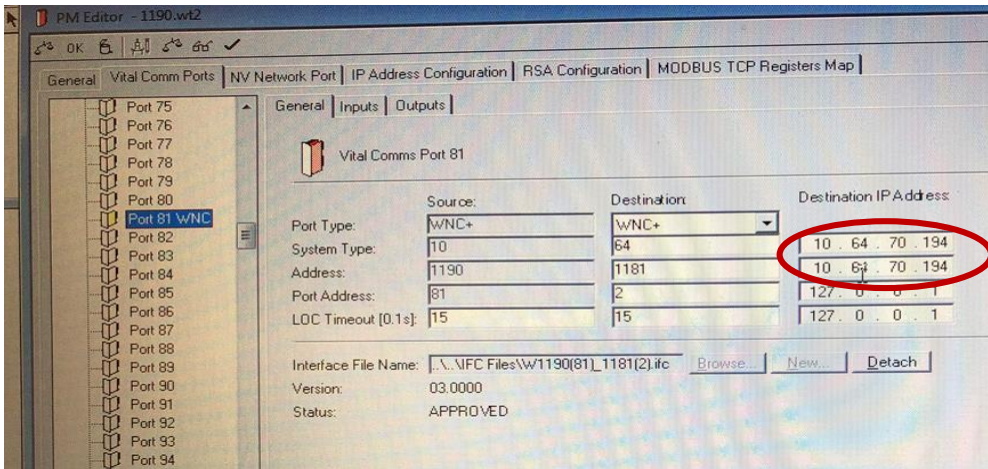
IP Addresses

During post commissioning works it was discovered that the axle counter “B” link was not communicating due to a duplication of the IP address. Investigation showed that the IP address for the interlocking processor “A” and “B” network was duplicated in the Axle Counter Processor (ACP).

A latent defect in the system diagnostic software masked the error initially, showing both A and B systems as operating correctly.

All design, project engineering and testing staff should be aware of the criticality of correct IP addressing, understanding that duplication or error can result in a loss of duplicated systems.

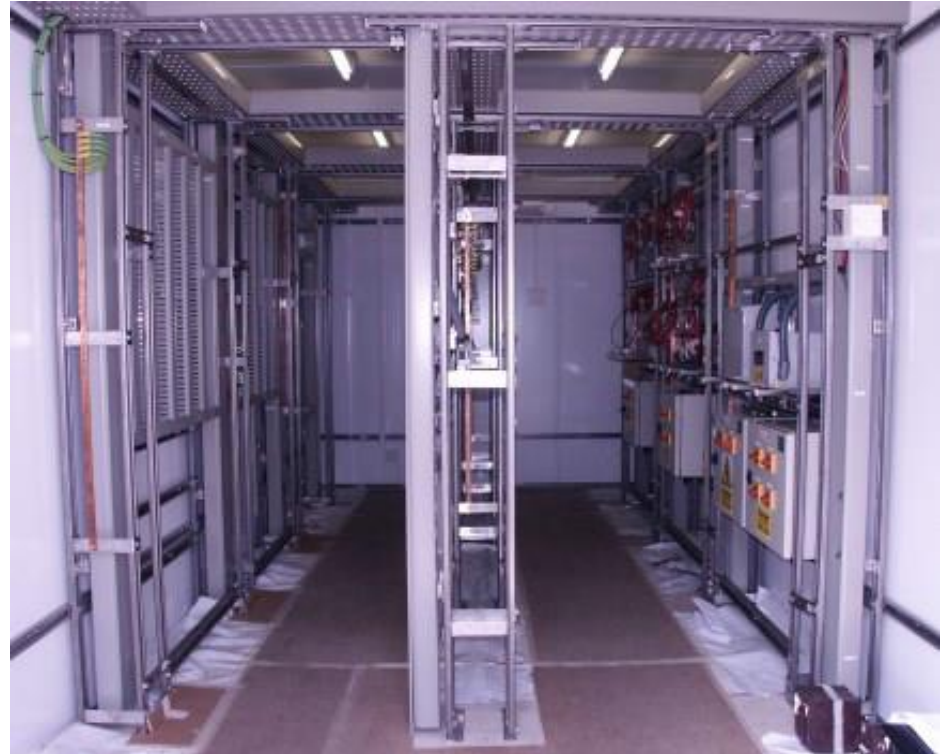
Soak testing

A Signal Module failed shortly after commissioning causing train delays. The module had generated a number of alarms during soak test. Constrained programme issues meant that installation works were continuing during the soak test period. The genuine alarms were not being distinguished from alarms caused by installation works and therefore not being fully investigated prior to commissioning.

During the soak test period project staff need to monitor ALL alarms and diagnostic information. This will in turn enable the team to react to alarms (identifying erroneous alarms caused by planned works) and rectify any issues prior to commissioning.

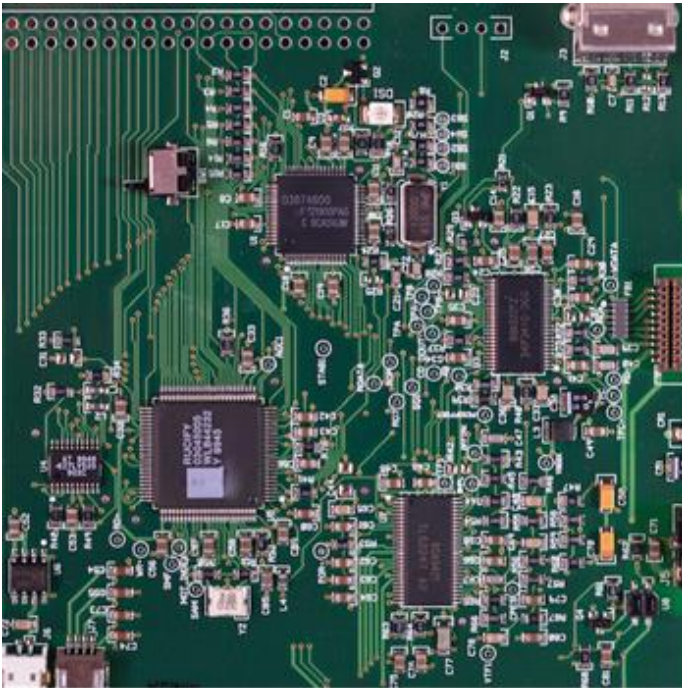
Computer Based Route Setting

A number of issues have been experienced with computer based route setting systems, causing an increase in delay minutes attributable to the route setting functionality.

- Failed update of software, attempts caused whole system failure.
- Intermittent failures on A and B links, leading to a momentary loss of route setting sub-areas.
- Instances of timetable not downloading or unpacking correctly requiring reboot of the Timetable Server.

However, it is important to use test systems that have both the target hardware and firmware versions.

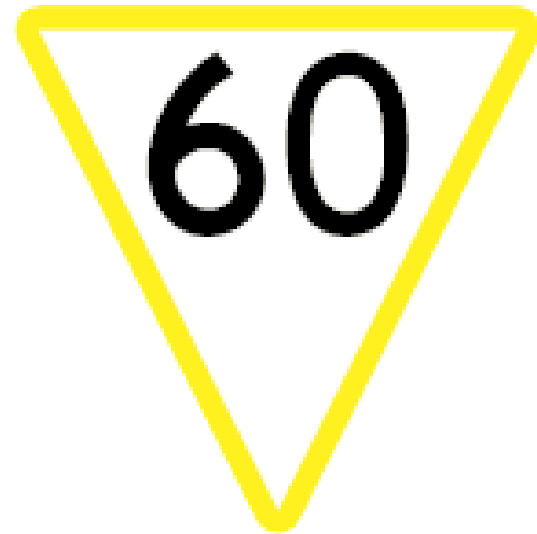
Permanent Speed Restriction AWS

A train approaching a signal did not receive an AWS warning when passing over an associated Permanent Speed Restriction (PSR) magnet, for a diverging route.

The erroneous suppression of the PSR magnet only occurs during, or after, a diverging route including flashing aspect sequence is set after the main route has been taken and released, where the magnet is correctly suppressed.

The magnet suppression function would have been latched for the main, straight route, but the latch is not removed by manual button pull, but is by TORR (Train Operated Route Release).

A data error affected this signal and others in the same interlocking.

Designers need to consider carefully where the introduction of complex controls are absolutely necessary. Data designers and testers need to understand how latch controls are set and unset.

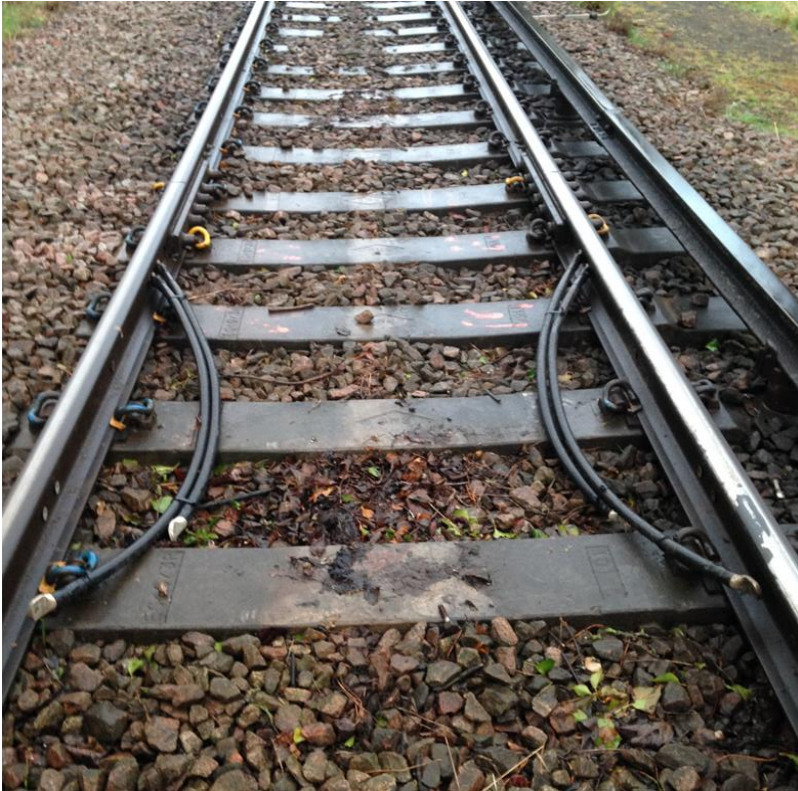
IBJ Bonding

After a successful resignalling commissioning, a proving train on a single line suffered traction problems (loss of line light) and could not complete its journey.

On investigation it was discovered a number of bonds which should have bonded around, a now redundant IBJ had not been fully installed.

This omission could have caused a serious safety incident and did incur a significant amount of delay minutes.

Robust assurance checks are essential to ensure the integrity of the infrastructure prior to handback and completion of the required paperwork.

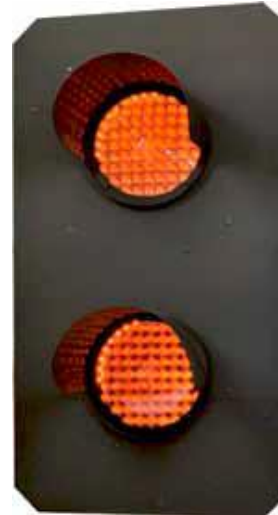
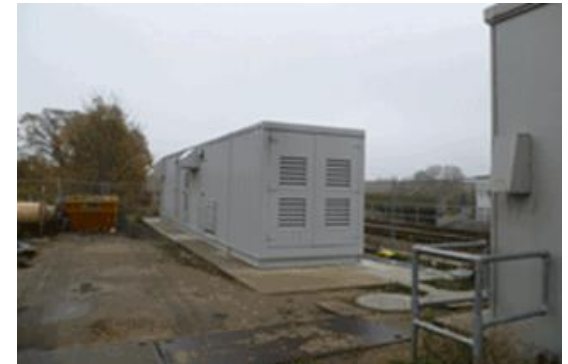
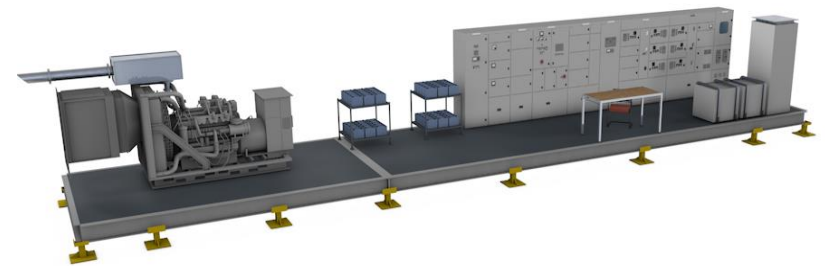
Power Supply Source

A recently re-locked area reported several changes of aspect. The Technician's Facility reported various Output Interface Disabled, Signalling Supply Frequency out of range and Voltage out of range alarms.

The signalling power was derived from a DC traction supply and the issues were resolved by transferring to a DNO (Distribution Network Operator) supply.

Electronic systems require a 'clean' power supply and incorporate checks on the quality of the power supply and isolate it when it is out of an acceptable range. This is more problematic on projects where the signalling power supply is not being renewed at the same time as the interlocking.

Consider where the signalling power supply is derived from and if it is suitable for the equipment being supplied.

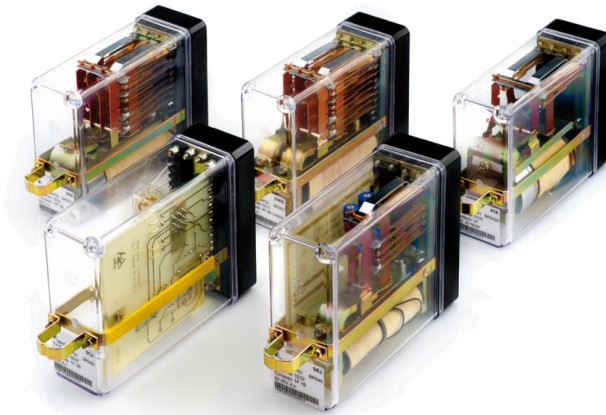
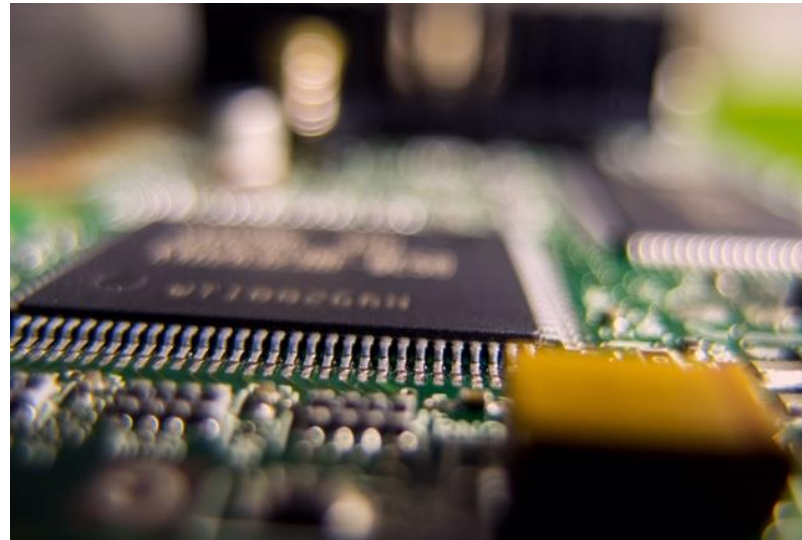
Solid State Object Controller Output Cards

During a commissioning a significant number of relays were changed as a result of alarms being received stating that the card output drive current was over the 250mA threshold for the particular system.

Subsequently the same type alarm has occurred on other functions and further relays were changed.

The 250mA limit is around the current capacity for the output card, however the alarms being generated do not have any operational impact.

Applications of solid state cards should consider the objects to be driven and/or number of outputs used. This also needs to consider the threshold of the alarms so as to avoid excessive alarms.

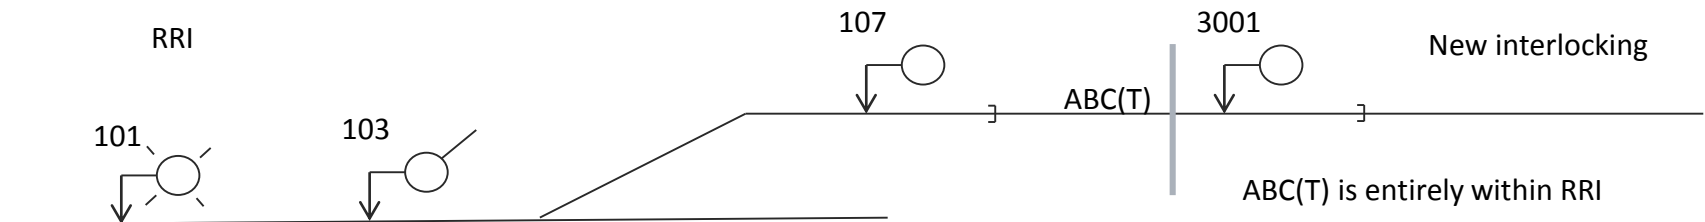
Cross Boundary Data

A standard data construct used in a new interlocking caused a signal in an adjacent RRI interlocking to act as a “double red”. Investigation revealed a track circuit occupied function combined with an aspect lit function that was not required. The project remit did include detail on the specific conditions to be used in this instance, but this was not implemented.

With the original functionality, junction signal 103 would step up to single yellow when a second train was routed via the divergence after the first train had cleared the overlap of 107. With the new functionality, junction signal 103 is prevented from stepping up to single yellow until the first train has cleared ABC track as well. This inhibits the flashing yellow sequence provided by 101 signal, until the first train has cleared ABC track causing a consequential delay if the following train is also routed via the divergence.

Designers and testers need to ensure consistency between data and wiring in fringe designs.

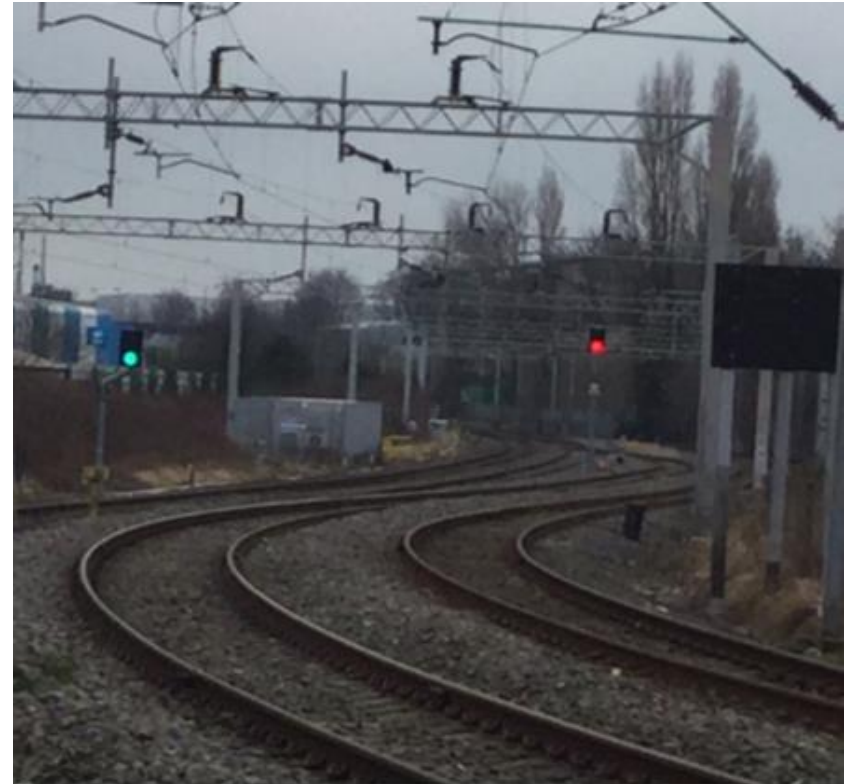
Signal Alignment

Post commissioning reports of poor signal visibility or dim signals have been received on a number of projects, due to signal aspects not being aligned in accordance with the Signal Sighting Assessment Form (SSAF). The alignment is particularly critical on 3° narrow beam LED signals.

[NB165](#) published in October 2018 gives clear guidance on the responsibilities of the Installer, Tester and Sighting Committee in the set up and assurance of alignment for signals and indicators.

It is considered best practice for the Signal Sighting Chair to complete the final sighting checks as part of the commissioning.

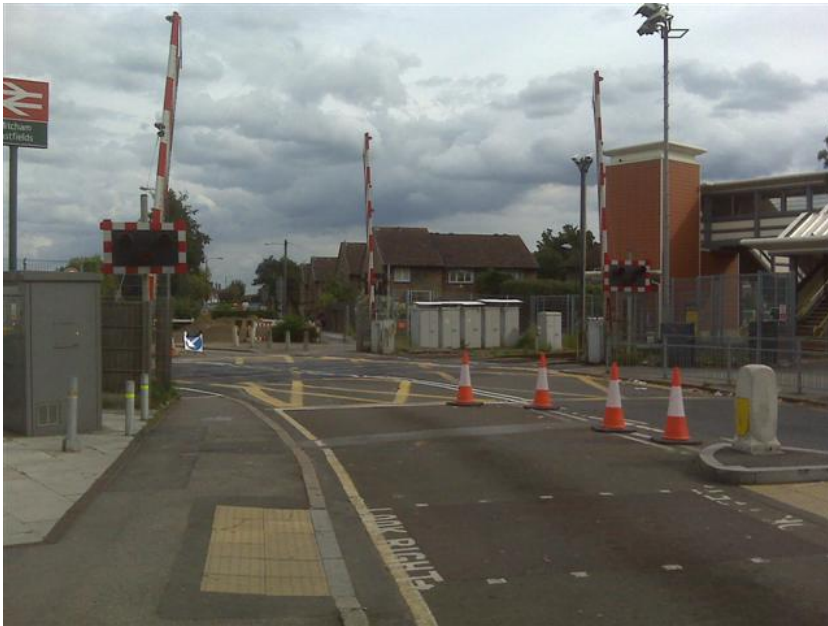
Level Crossing Fail to Raise

A fault was reported that an MCB CCTV level crossing's barriers had failed to auto-raise, after the passage of a train..

A route was set in the Up direction followed by a Down direction route, which was then cancelled.

The train traversed in the Up direction, but the auto raise control was still waiting for the Down train and the barriers failed to raise.

The auto raise function had operated as designed, requiring either the Down train to run and cancel the route or the Signaller to manually raise the barriers.

This unusual sequence of events and how to manage it had not been communicated to the signallers.

Designers need to understand and communicate the implications of how the data has been written.

Differences in operation to be briefed to Signallers and contained within the signaller training material, as part of the project training.

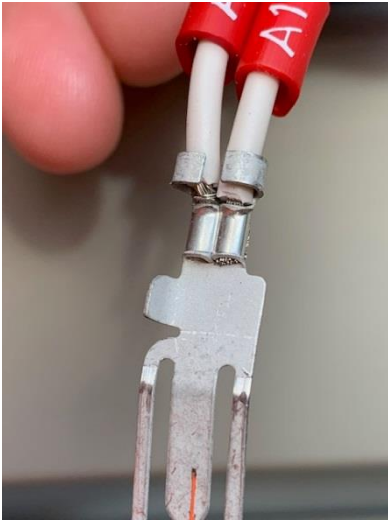
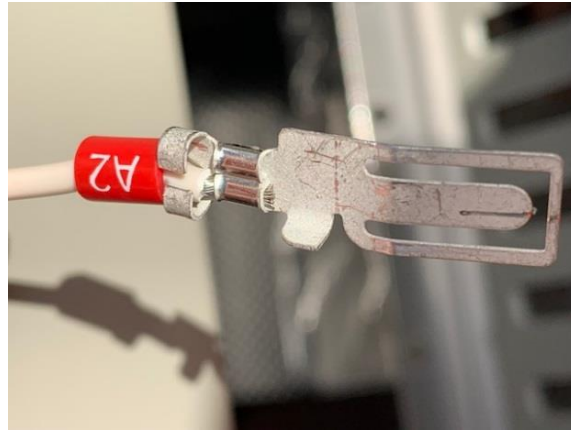
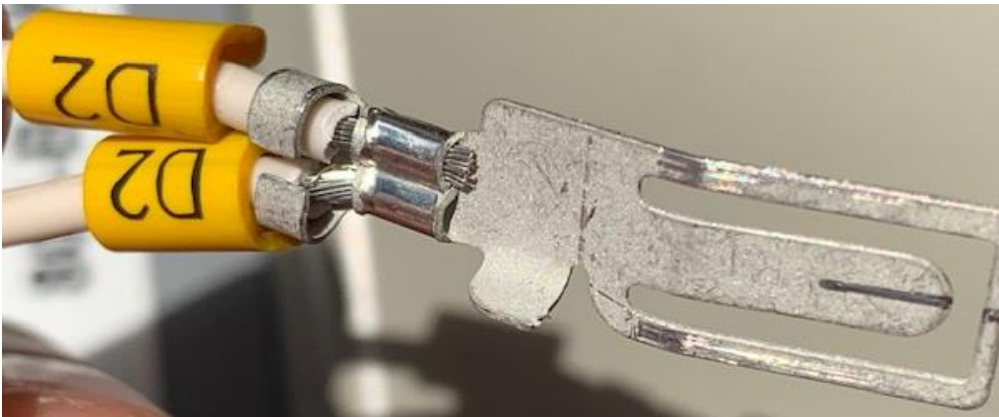
Crimp / Crimping Quality

A project recently discovered numerous poorly made Q crimp connections. These have been supplied in location cases for several other projects.

Test crimps should be made available to testers, and quality checks undertaken.
All tools should be fully calibrated and have up to date certificates.
