HSQE Briefing March 2018

In this edition:

- S.M.T.H. standards have been updated (March 2018)
- Safety Bulletins
 - Work group crossing open lines (With Live 3rd Rail)
 - Worker twists his ankle on site
 - RRV hook fails while lifting 1 ton bags
 - RRV topples over
 - Vacuum lifter failure
 - Electrical conduit accidentally cut through
 - PC Responsibilities, checking paperwork

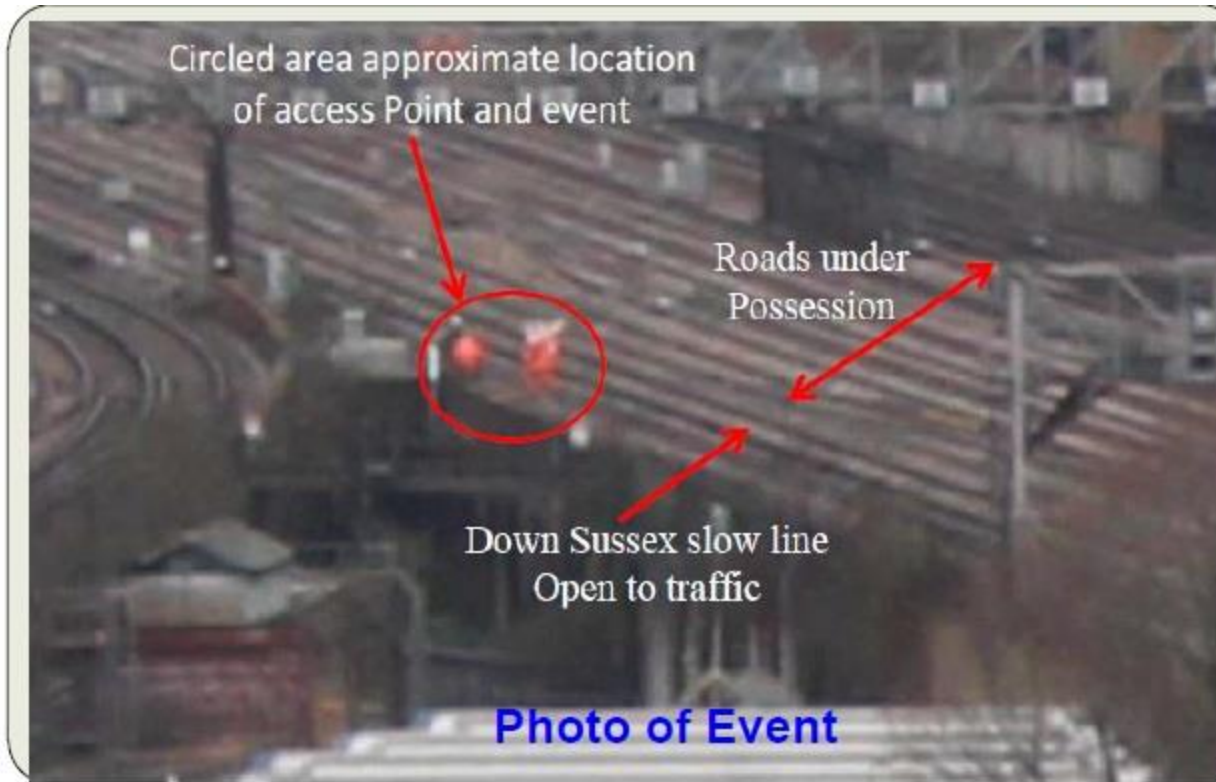
While crossing the open lines one of the group noticed a nearby signal displaying a green aspect, at the same time one of the team is reported to have stood on an energized section of conductor rail and received a "tingling sensation". The COSS then realised this part of track was open to traffic and immediately led his team to a place of safety.

- Team crossed an open line.

- Re-training, assessment and monitoring of the COSS involved.
- Implementation of non-working COSS's to remove any conflict between production and safety.
- All Task Briefing documents for work in possessions, with the potential to impact on open lines to be reviewed by the contractor's safety team.
- For future possession work, open lines to be sign posted at the most appropriate point on site as a visual reminder to teams.

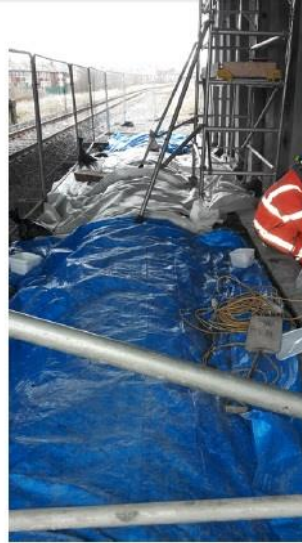
An Operative stepped down from a scaffold tower and went over on their ankle due to uneven ground and suffered a sprain which resulted in 2 days off work.

The tower scaffold used to access the work was positioned adjacent to a redundant ballast shoulder which meant that the access and egress from the tower was directly onto it. Due to the nature of the work area, the team were briefed that the ground was uneven and possibly slippery. This briefing was given as part of the task brief, the daily hazards brief and as part of the site induction.

The reason that the ballast was covered in visqueen, was to protect it from further contamination during the hydro demolition works.

From the picture you can see that there are many hazards that could cause a trip or a fall. Have a look to see how many there are but more importantly ask the question why haven't these been identified and suitable controls applied. Is it because we do not challenge the way we work enough or are we becoming more accustomed to hazards?

Identify these during the initial site walkout and pass them on to the designer so that they are considered during the design phase. In this particular case the ballast shoulder was redundant and could have been levelled off.

This should focus on the protection of the individual in the first instance rather than the asset. We actually introduced a hazard by putting down the visqueen.

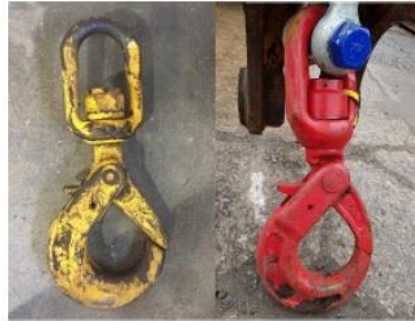
Whilst unloading one tonne ballast bags using an RRV and bag lifter the castellated securing nut on the lifting hook worked free and became detached from the coupling ring. The hook and bag lifter had been used several times within the shift, however as the Crane Controller attached the bag lifter to the next bag of ballast, and instructed the Machine Operator to lift the bag, the castellated securing nut came off and the hook separated from the RRVs boom.

The investigation has identified the failed hook is similar to the yellow one shown in the LH picture above, This has a castellated securing nut with a bronze bush and is NOT designed to be rotated with a load suspended.

The red hook in the RH picture has a ball bearing swivel and can be rotated with the load suspended.

Crane controllers and Machine Operators are to ensure they recognise the type of lifting hook fitted. If they have a lifting hook with a castellated securing nut the load should not be rotated whilst it is suspended.

- Prior to commencing lifting operations Crane Controllers and Machine Operators must satisfy themselves that they recognise which type of lifting hook is fitted, and its correct method of use.
- The plant hire company involved has instigated a campaign change of all hooks on their machines.

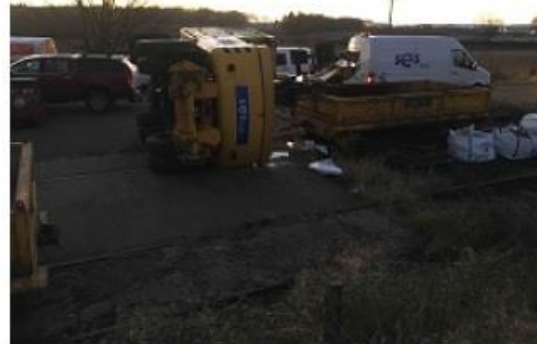
To allow for easier access one of the Atlas machines was used to lift a trailer and an attached ballast box. Lifted together, they exceeded the safe capacity of the machine.

The Atlas machine had a log grab attachment fitted. Lifting chains were connected through the log grab rather than removing it and properly attaching the chains. This was a contravention of the contractor's policy. The Atlas machine was in dig mode meaning that the safe load device (a Rated Capacity Indicator - RCI) was inactive for the lifting operation. The trailer and ballast box were lifted and as the machine swung round it overturned, coming to rest on its side on top of the trailer.

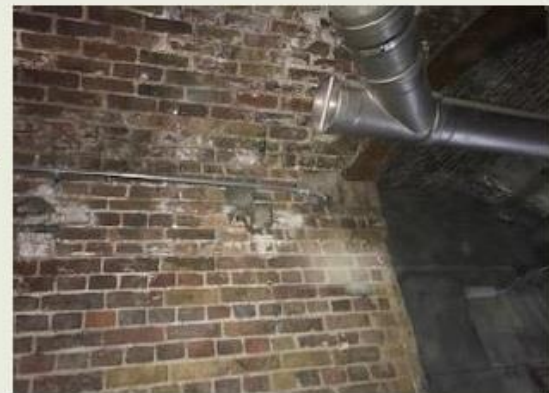
Whilst undertaking 'soft stripping' works, an operative cut through a live conduit using a reciprocating saw. The isolation certificate issued for the works had not taken into account a live conduit which had previously been installed above a false ceiling. The operative believing the conduit was part of the soft strip cut through it in preparation for removal.

Photo of electrical feed that was cut

Error-proofing conditions: An Isolation Certificate had been completed, however, this document was substandard and did not detail the location of the live electrical conduit as part of permanent work.

- The orange end process has been documented and communicated to all project persons to include services that are cut and removed from the work area and where removal is not feasible then isolated services be clearly "orange ended" at sufficient locations such that the operatives undertaking the works can clearly see the service. If any live services remain live in the area they must be clearly marked and protected on site.

- The revised isolation certificate now includes the requirement to undertake joint site visits to the area prior to any works. The permanent and temporary design drawings are to be reviewed and confirmed by the CRE for Fire Alarm, Electrical and Mechanical services representatives prior to work commencing.

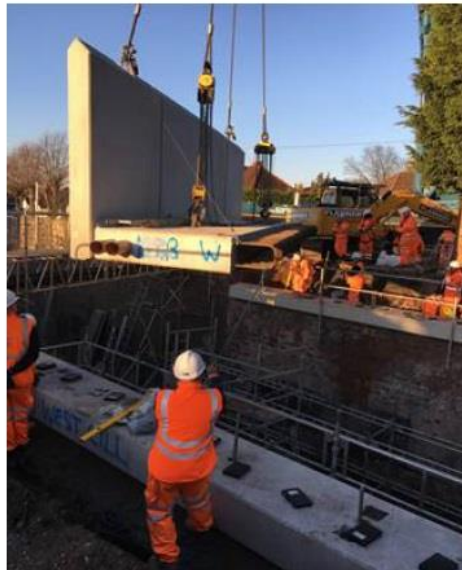
During a site visit by Network Rail's Head of Safety & Sustainable Development to Parkfield Road Overbridge Reconstruction project, significant shortfalls were found regarding competency records, plant certification and briefing checks.

- During the T Minus process identify what documentation is required to be reviewed and at what stage e.g. WPPs are required 28 days prior to the work starting. The IP Renewals team are looking into how this can be mapped.
- When reviewing the Construction Phase Plan or Work Package Plans the checklists held on Safety Central should be used for consistency by both the Supplier and the Project Team.
[CPP Checklist](#)
[WPP Checklist](#)
- Responsibilities of key individuals need to be defined and ensuring sufficient time to fulfil them is allocated.
- Adequate safety support needs to be provided by the supplier during the core works.
