# HSQE Briefing November 2017

- Winter Driving
- Near miss of track workers using L.O.W.S.
- RRV on tracked onto an open line
- Mobile scaffold tower comes into contact with live 3<sup>rd</sup> rail
- Failure of Tensorex OLE support bracket

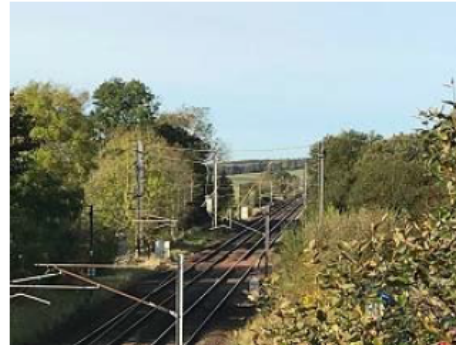
On the morning of 29 September 2017 red zone working, by use of Lookout Operated Warning System (LOWS), was in place by to allow survey work for the High Output team to take place.

At 1010 the site lookout became aware of the approach of a train on the Up line due to hearing and feeling the vibration of a freight train on the rails.

The group had not been warned or alerted of this train by the LOWS system.

They were warned by the site lookout and moved clear and into a position of safety. One member of staff was walking on the Up line when the train approached and reached a position of safety 5 seconds before the train passed.

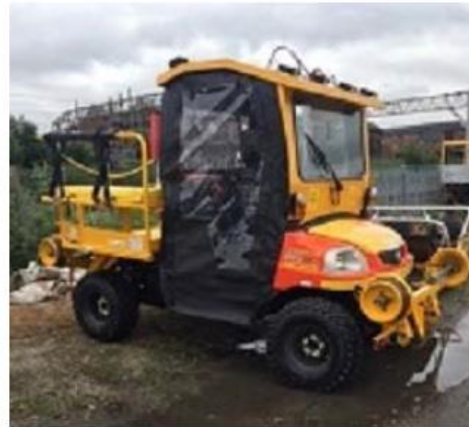
At 00:02 on 3 January 2017 a Kubota road rail vehicle was placed on an open goods line during a T3 possession of the adjacent main lines at Rookery Bridge between Crewe and Sandbach.

The Engineering Supervisor (ES) was unfamiliar with the location and referred to the main lines at this location as both the "Manchesters" and "main lines". The Controller of Site Safety (COSS) took this to mean the Manchester Independent goods lines.

The access point cited in the Safe System of Work Pack (SSOWP) was Rookery Bridge, however this is located on the goods lines side of the railway and therefore is not viable when the goods lines are not included in the possession.

The Person in Charge should be involved in the planning – a key factor is to make sure staff such as the ES, the PIC (and if different the COSS) have local knowledge.

Use location names as they are stated in the Sectional Appendix to avoid confusion.

Worksite briefings should be face-to-face to enable staff to sign their acceptance of the worksite details.

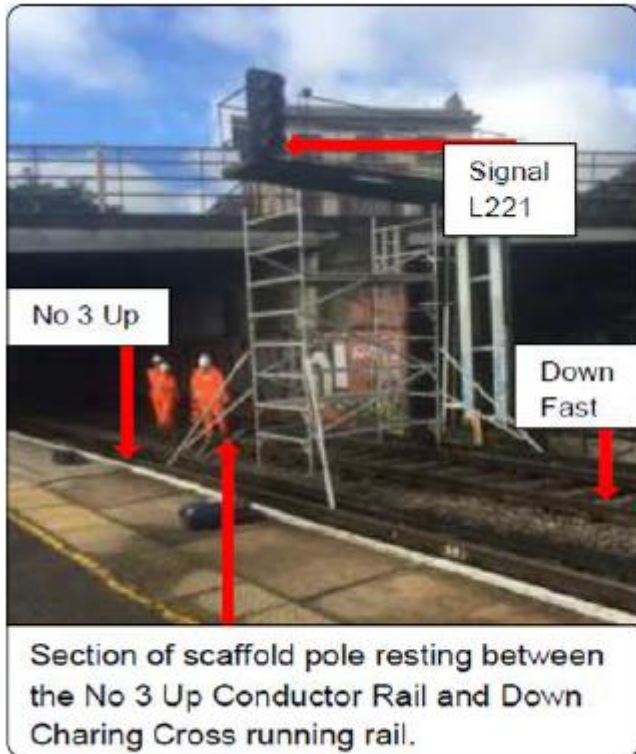
On 30<sup>th</sup> July 2017 at New Cross Station during a 2 Part Possession, a mobile tower was erected to inspect L221 Signal Gantry. The outriggers on one side were positioned between the conductor rail and running rail of No 3 Up Line. On the other side, both scaffold legs were positioned between the conductor rail and running rail of the Down Fast line.

As the possession moved into Part 2, operatives were dismantling the scaffolding, after carrying out a survey, when a scaffold pole was dropped and came to rest between the No 3 Up Line conductor rail and the Down Fast running rail, causing a flashover.

**Immediate** – Work party were unaware an isolation had been lifted on an adjacent line and a metallic scaffold pole came into contact with a conductor and running rail causing a flashover.

- COSS's used on Thameslink to have competency formally assessed.
- Introduction of compliance checks at site level, when scaffolding is used and to confirm understanding of possession arrangements.
- Increased frequency of random D&A testing to deter substance abuse.
- Site Supervision to undergo competence checks related to tasks they supervise.
- Contractor to ensure adequate site presence of supervisors.
- ES/AP's briefing for multi-part possessions are to be clearly communicated to all COSS's and confirmation received that they have a full understanding of the safe work limits for each part of the possession.
- COSS's to stand-down work teams and re-brief any changed arrangements when moving between parts of possessions.
- Introduce process to ensure version control and legibility of SSOW packs.

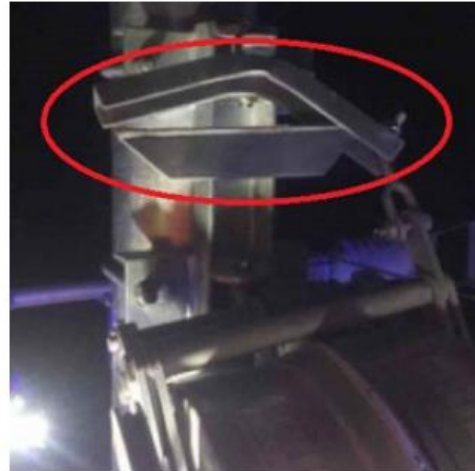
### Failure of Tensorex C+ upper fitting bracket in OLE

On the evening of 28 August 2017 the failure of a Tensorex Upper Fitting Bracket (Pfisterer part number 042216) was discovered in the Overhead Line Equipment (OLE).

Investigations indicate that the failure of the bracket was caused by poor quality welding of the stiffening plate during manufacture. This in turn caused a secondary failure of an M14 terminal fork.

1. identify all locations where they are installed;
2. inspect all installed brackets; and
3. check all brackets in stores for poor quality welding.

The inspection should focus on the quality of the welds, damage to the weld and insufficient welding of the stiffening plate.

Any unit which has been fitted with the 042216 upper fitting bracket, and has subsequently failed the visual inspection should be retrofitted with a replacement part fully compliant to the design specification at the earliest possible opportunity.

To assist with future identification of any Tensorex C+ units which have passed the inspection criteria, or are retrofitted with a replacement upper fitting bracket, shall be clearly identified by way of yellow dots on the underside of the upper fitting, directly below both terminal fork positions.
