# Health and Safety Briefing

## Infrastructure Projects - Signalling

## SHEQ Information No. 260

London Bridge Station Redevelopment, Forklift Accident – 3rd Feb 2013

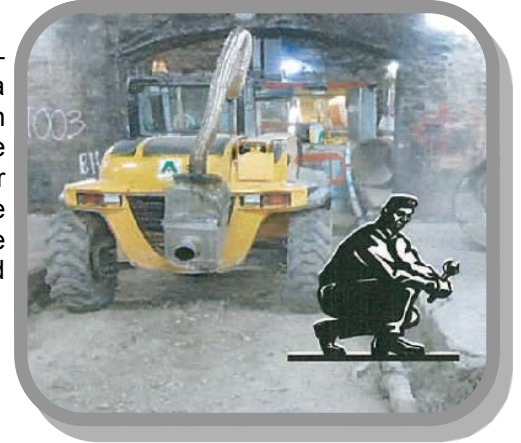
**D**uring general construction activity within the arches area of the station, a banksman sustained bruising when his foot / ankle was struck by a reversing forklift. The forklift had previously been moving forward when the banksman noticed a missing clip from a concrete delivery pipe. The banksman signalled for the forklift operator to stop, which he did, however whilst the banksman was bent down to the rear offside of the forklift, the driver decided to make a reverse movement and in doing so struck the banksman. The photograph on the right shows the position of the injured person when the forklift reversed and caught his foot.

**S**ite briefing to include details of plant operations/movements and possible interference with other work

People and plant should be segregated completely (minimum 2 metres)

Clear communications should be reached between the banksman and the operator

Where plant is fitted with safety devices such as mirrors, reversing alarms, reversing lights etc. these must be in working order at all times

Operators must not make any manoeuvre of plant or vehicles without the authority of the banksman Individuals should never cross in front or behind plant or vehicles without first gaining the attention and acknowledgement of the operator

Medication should always be declared to the employer

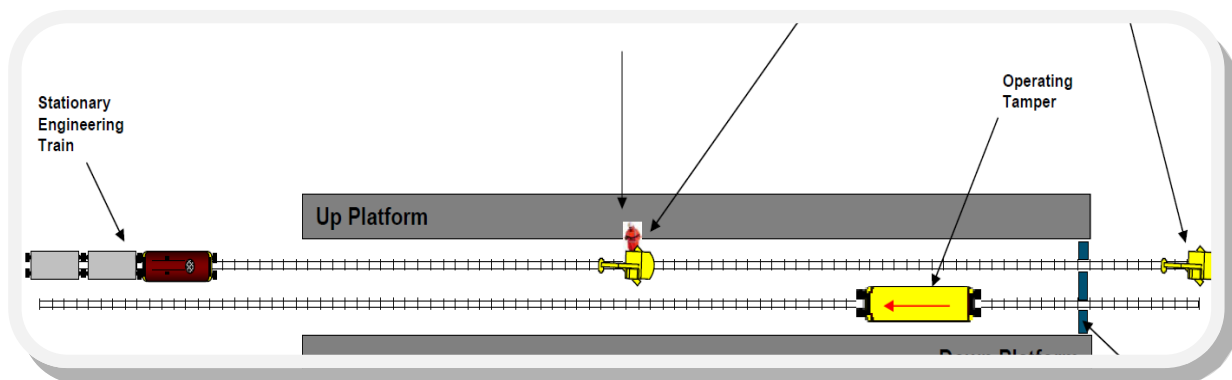
Whilst undertaking track renewal work between station platforms, two S&T Technicians were standing on the Up Line observing cables during tamping operations on the Down Line. A RRV approached on the Up line. One person dived clear, however the second was pressed against the platform edge and was trapped between the RRV caterpillar tracks and the edge of the platform coping stones.

The injured Person was taken to hospital and released later the same day with bruising to his leg and ankle – **this could have been significantly more serious and is being investigated as if it was a fatality.**

1. Always consider if the place required to observe the infrastructure, is a safe place to stand.
2. RRVs should travel at walking pace when in worksites. If a RRV is observed exceeding walking pace, then inform the site management and raise as a close call.
3. RRVs should always be under control of a machine controller when in a worksite. If there is no evidence of a machine controller, then inform site management and stop the job until this is rectified.
4. When a worksite passes through a station the risks change and the safe system of work should be updated.

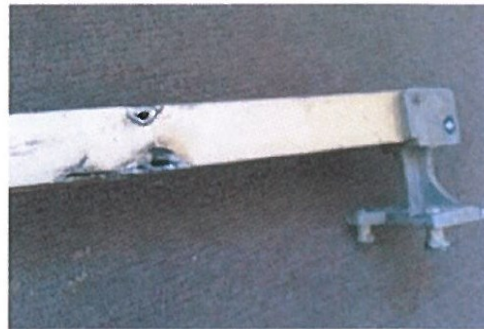
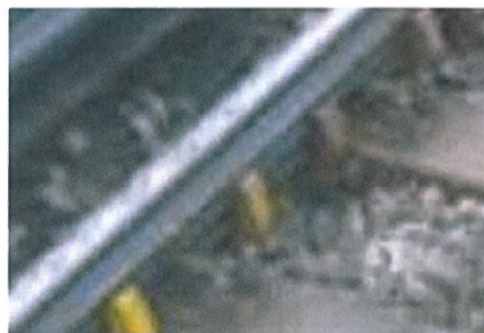
A non-insulated cant gauge was used to confirm the track geometry after completion of platform extension footings at Bentley Station, Hampshire.

As the Track Handback Engineer checked the track after completion of works, he lifted up the gauge which then released the spring loaded end, causing it to jump and come into contact with the live conductor rail and running rail. Fortunately, the Engineer had let go of the gauge which prevented him from suffering any electric shock and burn injuries.

The gauge was burnt and significant damage to the rail head over a 10 sleeper area was sustained.

**ALL** tools and equipment (including shovels, bars, track gauges, tapes) used in the vicinity of the 3rd Rail **MUST** be insulated.

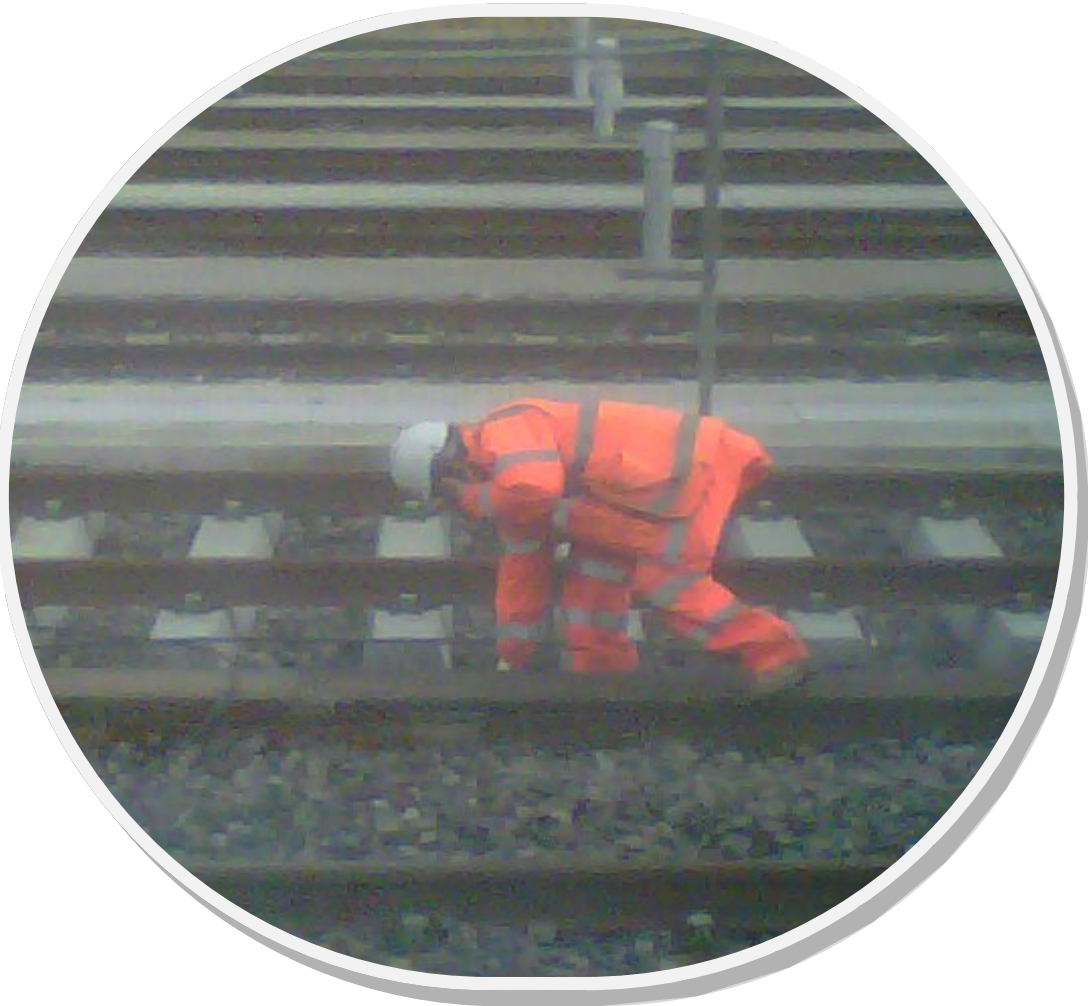
This picture was taken from a train which was passing at slow speed. He was on his **mobile phone with one hand**, and **pulling a cable with the other hand** at the same time!

1. **Could he see the warnings?** - Probably not.
2. **Could he hear the warnings?** - Probably not.
3. **Is he more likely to fall?** - Probably and also injure himself.

The PC would re-brief all staff about being safe and to be able to look up and walk to a position of safety.
