HSQE Briefing November 2019

This Months Safety Cascade

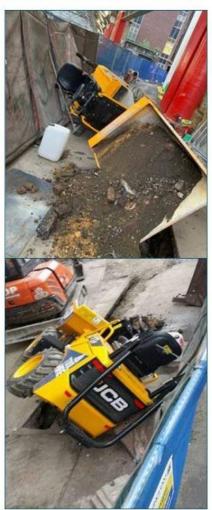
01 October 2019 – Dumper Truck Overturning

On the evening of 01/10/2019, the Liverpool Lime Street Shift Station Manager/Security Team noticed the small dumper, which was being utilised for work in relation to the new drainage scheme for the train Crew Signing-on Point, had fallen into a previously excavated trench within the worksite area. The machine, with its bucket loaded with material, is now lying at an angle of 30° and has struck a fence erected to segregate the train crew walkway from the works.

Initial reports received from the PC are that the hand brake had not been applied, the vehicle was on a slight incline and had rolled down into the trench. However, this will need to be established by the investigation.

- An alternative walking route has been established for Northern Trains train crew
- PC righted the dumper

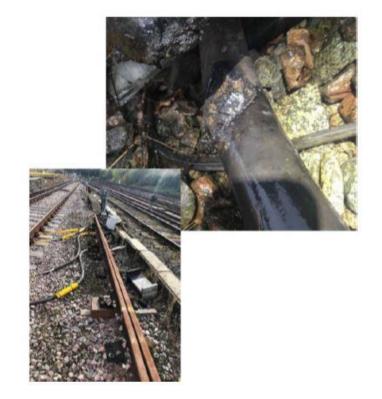
Scrap Switch and Stock in contact with live 650V Conductor Rail Cable

During routine maintenance the Hither Green S&T Technicians identified a rail chair from redundant S&C next to L922 points was laying on a 650v DC cable and had cut into the insulation. The technicians immediately called the incident in and arranged for an isolation with Track and ETE Teams attendance to lift the S&C Clear of the cable and for the cable to be repaired.

A Fault was logged and a Close Call created to remove the redundant S&C

A Level 1 investigation is being undertaken to identify the immediate risks and actions and how long the S&C has been in place and whether opportunities to remove that risk before it became live had been missed.
