**HSQE Briefing**  
**October 2019**

# Safety Bulletin

## Trench collapse causes specified injury

Ref: NRB19-16

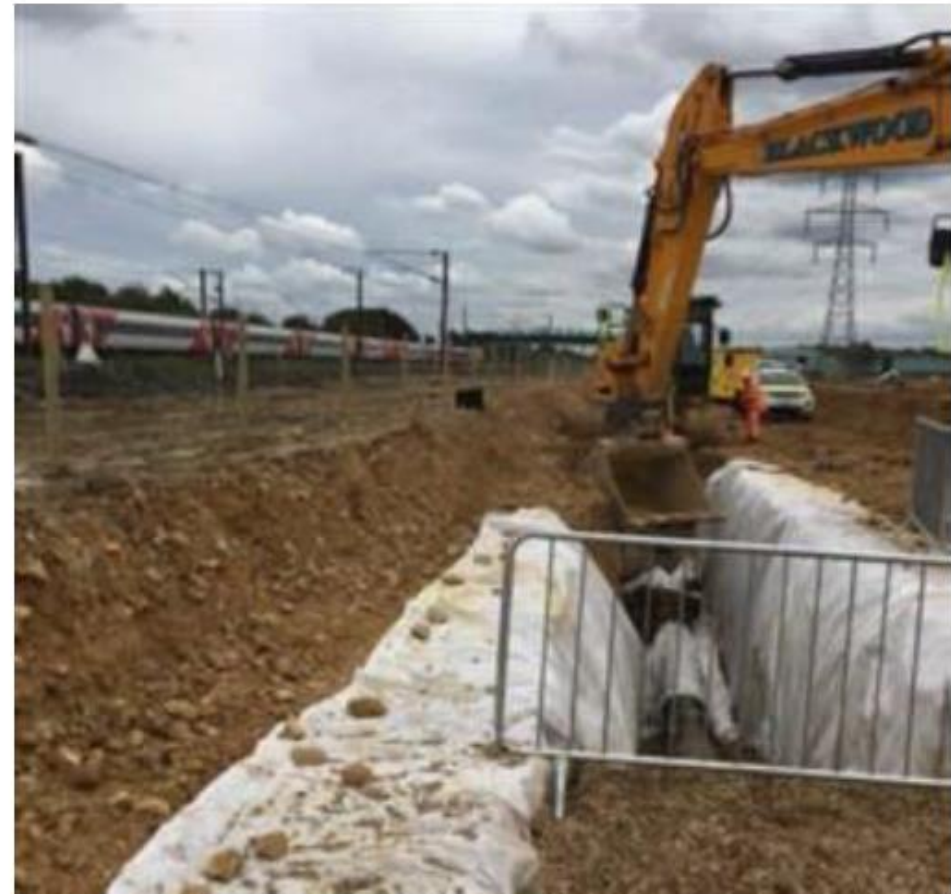
On 30th September during installation of drainage works, at Stamford Underbridge, a survey levelling rod was left in a trench by mistake. A trench box had been in use earlier but not when a supervisor entered the trench (2.5 – 3.0 metres deep) to retrieve the rod.

As the supervisor was leaving the trench a section of the unsupported clay wall fell and struck the supervisor's back and legs causing them to fall to the trench floor.

The injured person was taken to hospital by ambulance having sustained a fractured pelvis.

- NEVER assume that it is safe to enter or work in an unsupported trench or excavation pit.
- ALWAYS check that the appropriate controls are in place and permit requirements are met.
- While this accident is being investigated, please discuss the following with your team;
  1. How does risk awareness 'drift' on your sites? What do you see?
  2. When and how are you using safety conversations to embed risk awareness and safe practice on our sites?
  3. Discuss the importance of the responsibility to stop and challenge unsafe practice.

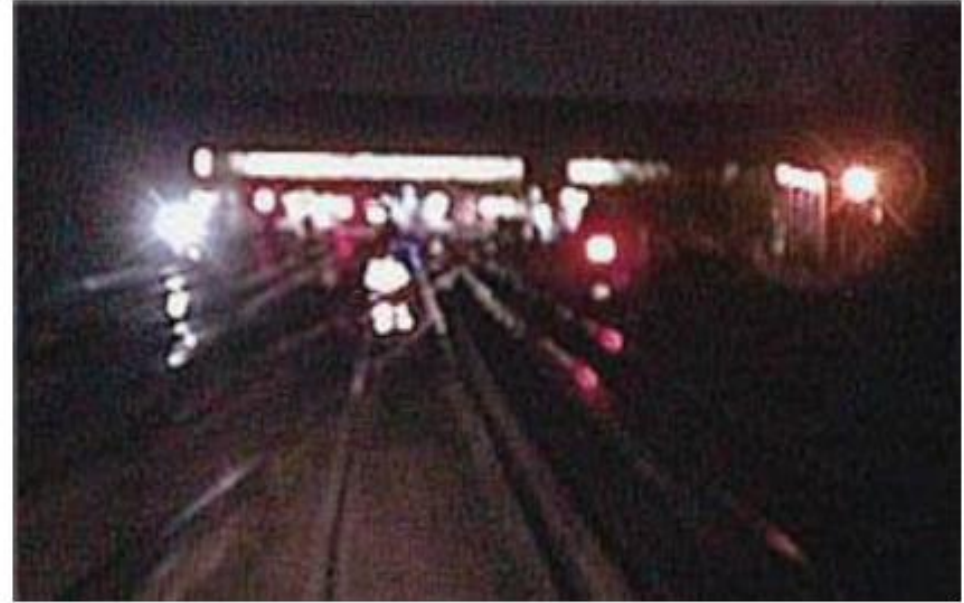
Ref: NRL19-14

At 23:24 hrs on 2 December 2018, a track worker narrowly avoided being struck by a train between Horley and Gatwick Airport stations, on the boundary between Surrey and West Sussex. The track worker was a controller of site safety (COSS) who, together with a strapping operative, had gone onto the railway to remove short circuiting straps.

The COSS moved out of the path of the train, around one second before it reached him, when it was travelling at around 35 mph (56 km/h). Nobody was injured.

The Network Rail isolation planning process meant that BAM Nuttall planners lacked the information needed for them to establish the exact location at which work was to be carried out on the track.

The planners lacked the skills and experience needed to understand this and so provided a system of work which provided no protection from train movements at the actual location of the task

The COSS recognised that the planned system of work lacked adequate protection from train movements, but undertook the task without implementing an alternative safe system of work. He wasn't challenged by a colleague.

- It is essential that track work is undertaken in accordance with the approved safe system of work, or after following the appropriate formalised system for establishing an alternative safe system of work.
- Challenging inappropriate safety behaviours, and applying a work safe process (stopping work if safety concerns are not resolved) when appropriate, are essential for everyone's safety.
- Safe work planners must seek additional information before completing a safe system of work pack if they lack the detail of the task needed to confidently plan it safely.
- The value of sounding the train horn as a warning if drivers see people in, or possibly in, a position of danger was demonstrated during the Gatwick incident when it almost certainly saved the life of a worker involved. The rule book requires the warning to be given as repeated short horn blasts.

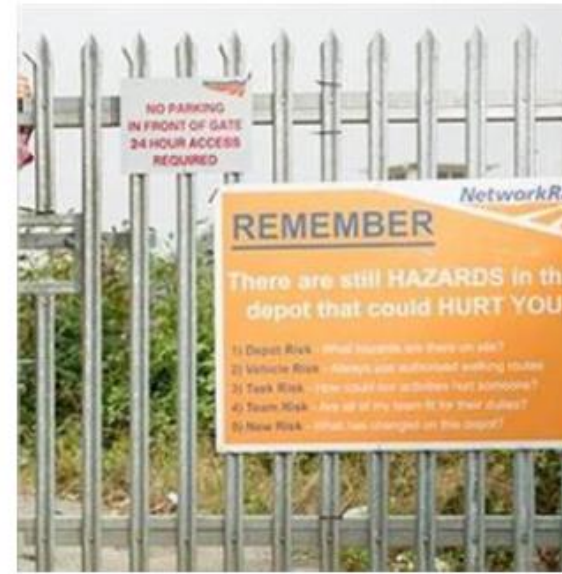
Ref: NRA19-13

Signs on access gates across our infrastructure are a valuable way to provide safety information, especially to confirm line designations, emergency numbers etc. But they can also cause a 'sail effect' in high winds.

There have been reported cases of people being injured when the gates move in high winds. Some gates also become cluttered with signs which can result in the essential safety messages being less obvious.

- Review the signage fixed to all access gates.
- Consider if the signage is required.
- Consider moving signage to the fence lines or a designated site entry board.
