# Resourcing Solutions' HSQE Briefing: March 2017

- Use of Brush Cutters fitted with a metal blade for de-vegetation works
- Working at Height
- Temporary clamped joints for construction
- Retractable spring loaded craft knives
- Insh Marshes Category 1 Environmental Incident

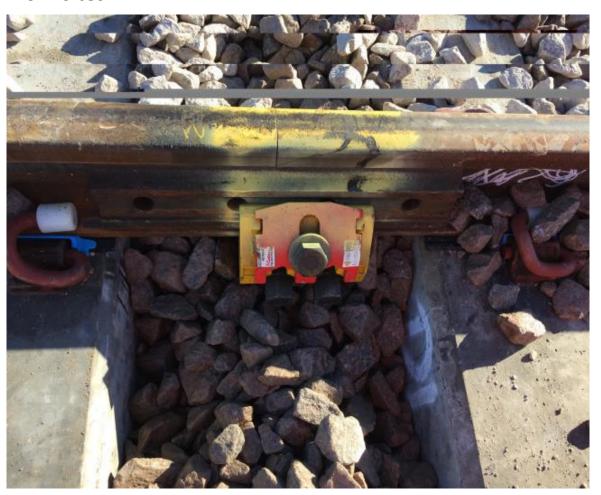
# **Temporary Clamped Joints for Construction**

There have been several failures of temporary clamped joint under traffic on S&C North Alliance work sites

# Temporary clamped joints for construction

- An underlying cause of these failures is that the temporary clamped joints were not correctly assembled at the time of initial construction on the work site.
- In essence "Temporary" clamped joints were being formed (an example is shown on the previous slide).
- Reasons given for doing this were to pass rail vehicles in the worksite over the track under construction
- The method shown on the previous slide required the Supervisors to remember to remove or finish the construction of such joints later on prior to hand back.
- However, due to time pressures, the welding or addition work required to finish compliant construction of the joints was not carried out or confirmed to have been done.
- The non-compliant joints were not corrected prior to hand back & failed under traffic. A derailment could have resulted

- Any temporary clamped joint that is not assembled in strict accordance with the manufacturer's instructions has a very high risk of failure. This failure can result in a derailment.

- Such joints must be formed in accordance with the manufactures
   assembly instructions. This is to ensure that they comply with Network
   Rails Product acceptance for use on operational railway infrastructure.
   This requirement is regardless of whether the joint is to be removed or
   rechecked during the works.

- Supervisors are required to confirm that all temporary clamped joints are assembled correctly when initially fitted. This includes torqueing all nuts and fitting any locking mechanisms.

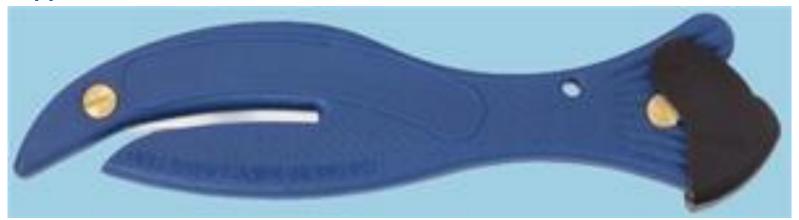
## **Approved**

# **CK Jokari T10700 Multicore Cable Stripper - 50 to 70mm**

Suitable for use with multicore cables from 50 to 70mm in diameter, the T10700 has a precision blade which automatically repositions itself to ensure a clean cut at all times.

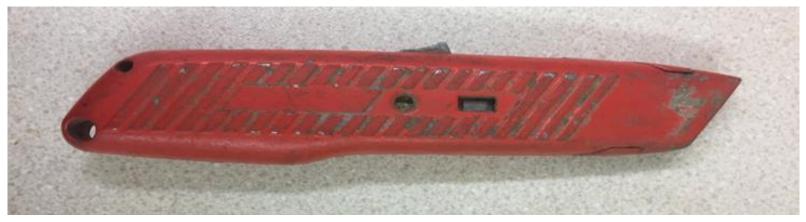
# **Banned**

# Retractable Spring Loaded Craft Knives have now been banned on all Siemens Rail Automation projects.
