HSQE Briefing

December 2018

Safety Bulletin

Electrical fire - staff injury

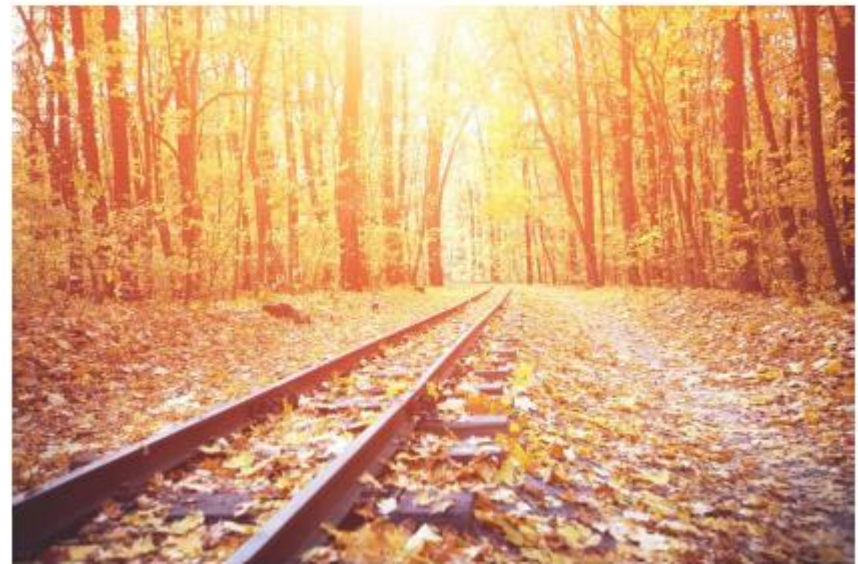
On the 30/11/2017 a TSS contractor suffered a leg injury when he stood on a manhole cover which gave way. One of his legs plunged down the chamber to waist depth resulting in an injury to his Right Knee. The Injured Person returned to work on the 29/01/18. The manhole cover had not been fitted properly by previous users and was also covered by leaves.

- **Lighting** - Is there is enough lighting around your workplace for you and your workers to be able to see and avoid hazards that might be on the ground? **Remember the days are getting shorter.** Ensure all team members have head torches.
- **Wet & Decaying Leaves** - Fallen leaves that become wet or have started to decay can create slip risks in two ways, they hide any hazard that may be on the path or they themselves create a slip risk
- **Ice, Frost & Snow** - To reduce the risk of slips on ice, frost or snow, you need to assess the risk. **Adjust your driving** – Reduce your speed and allow extra room for braking.
- **Health** – Wear appropriate clothing to stay warm

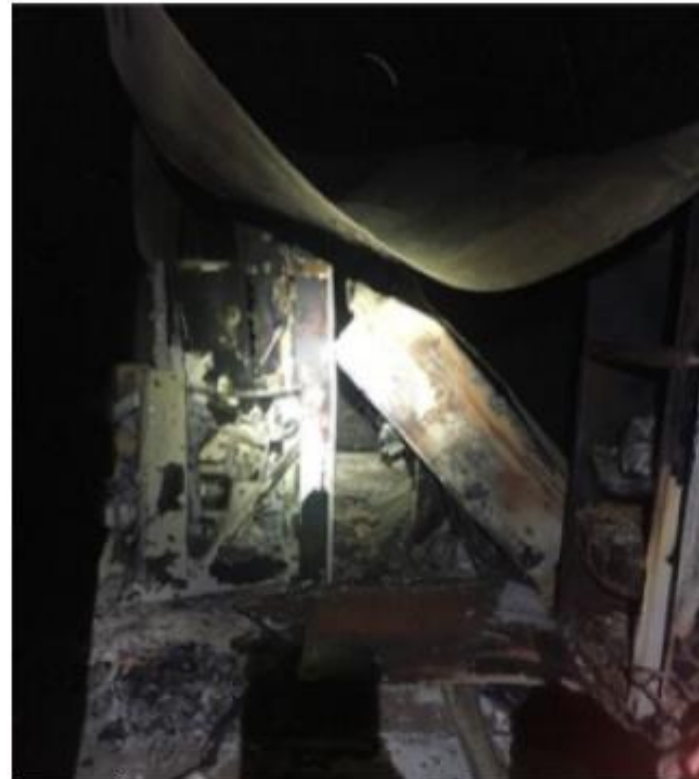
Whist E&P staff were attending to a fault at Godinton Substation on the evening of the 20th December there was a release of electrical energy (Flashover) when a member of staff attempted to replace a 750V, 2 Amp fuse which had blown earlier.

The flashover caused severe burns to the injured person. He attended hospital and was transferred to a specialist burns unit where he is being treated for his injuries.

The substation was substantially damaged by the fire that resulted (photograph above).

An immediate technical bulletin was distributed to Routes on 21st December. That advises no-one should enter the breaker cell in a Whipp & Bourne MM74 DC Circuit Breaker unless the incoming power is de-energised.

Never assume any equipment is isolated - always test before touch.

Always test before applying earths to electrical equipment.

Always wear the right PPE for work in electrical switch rooms including Arc Protective Clothing where appropriate.

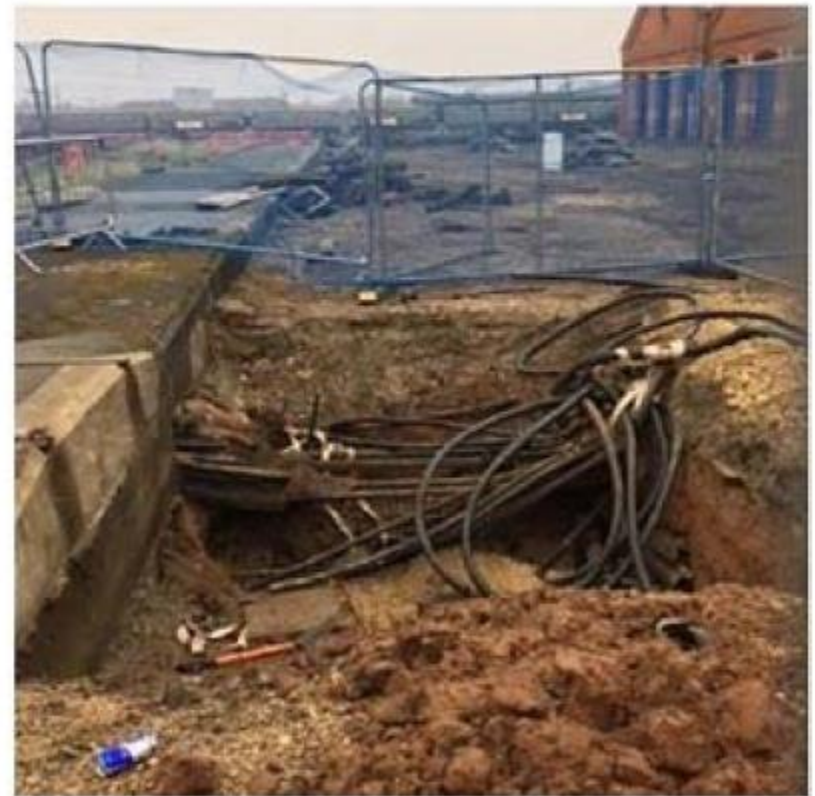
On the 15/11/18 at 11:30 hours an electrical contractor received burn injuries due to an electrical high voltage flash over while working in the depot. The Injured Person (IP) suffered burns to their left forearm and right hand which required hospitalisation and ongoing medical treatment.

The incident occurred when the IP was cutting into redundant cables using a power tool to remove them. The electrical cables being cut were considered "dead" as an agreed isolation was in place; however this was not the case and during the works the 11kV cable strike occurred.

- Has your task been thoroughly planned?
- Have the survey and records accurately captured all electrical conductors?
- Have the safety arrangements been reviewed by a competent person?
- Has all necessary safety information including permits and isolations been included in the Work Package Plan and Task Briefing Sheet?
- Are the briefing arrangements in place to ensure workers have and understand how to keep themselves and others safe?
- How do you make sure that you and your colleagues comply with the Life Saving Rule of "always test before touch"?

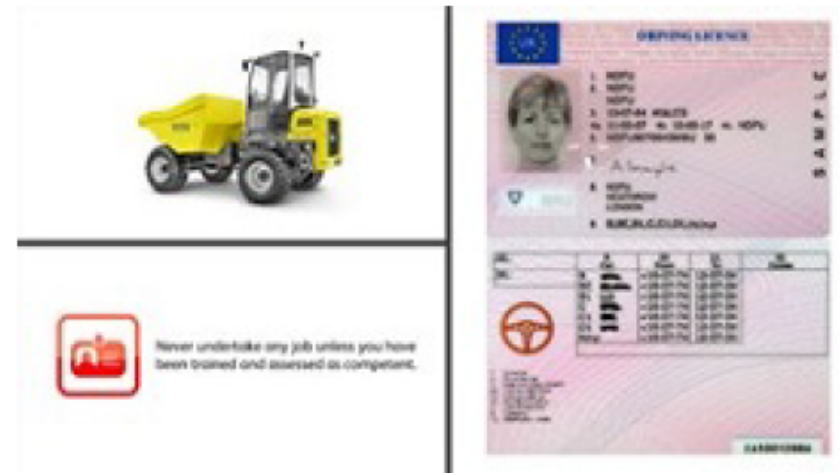
Following an accident where a hired 6 tonne Wacker Neuson DW60 dumper collided with a Pelican crossing traffic column, a design issue has been identified and addressed by Network Rail Bulletin NRB 18/19.

The dumper operator was a temporary agency worker transferring granular fill material during a night shift between the main site compound and another area via the public road – a journey of about 10 minutes.

The investigation has revealed that the operator of the dumper, while assessed as competent to operate the dumper and holding a construction plant safety certificate, did not have a driving licence to drive on the public road.

- The Principal Contractor failed to carry out a risk assessment for the use of this route, it was not planned and was not included in their Traffic Management Plan.
- The Principal Contractor had measures to manage the risk of construction plant on the public road including permits and checks but failed to implement them in this case.
- Key supervisory roles on the project were not aware of the requirements for taking construction plant onto the public highway.
- While competent to operate the dumper, the operator did not hold a driving licence.
- The operator did not challenge the instruction to use the public road between sites.

All site plant movements on highways should be limited.

Any plant movements on the public roads should be risk assessed with details included in a Traffic Management Plan.

Always check that required competencies, including driving licences, are in place for operating plant on Network Rail sites.
