HSQE Briefing February 2018

- PPE
- Mental Health contacts and tools
- Safety Bulletin
 - Leg injury
 - Electrical Fuse
 - O.L.E. damage and risk of electrocution
 - MPV struck branch resulting in brake failure and train runaway

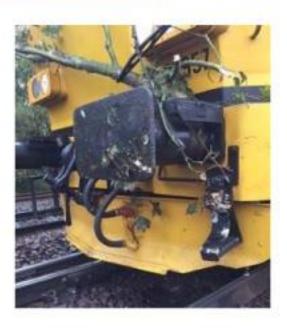
At approximately 04.00 on 17 October 2017 a Multi-Purpose Vehicle (MPV) was travelling between Ladybank and Markinch when it struck a branch which had blown from a third party tree during high winds.

At this stage the assumption is that the train's braking system became disabled due to the branch travelling sufficiently under the solebar of the MPV to cause damage to the air pipes and releasing the brake distributor cord on both the vehicles.

This allowed the MPV to start rolling backwards and at this point, as the train began picking up speed, the driver and operator both jumped from the machine with both sustaining injuries. The driverless MPV ran for a distance of over 4 miles, in the wrong direction, back toward a point between Thornton North Junction and Thornton South Junction before stopping of its own accord at low point on the route.

- What contingency arrangements apply following a report of high winds/severe weather events?
- What is your understanding of the operational procedures for managing risk post an adverse/extreme weather event and are they clearly understood and consistently applied?
- What immediate actions are to be taken on receipt of an emergency GSM-R Rail Emergency Call?
- How should a Signaller manage a train which is declared a runaway?
- How do you identify and report trees close to the railway boundary which concern you?
