Resourcing Solutions' HSQE Briefing: February 2017

In this edition:

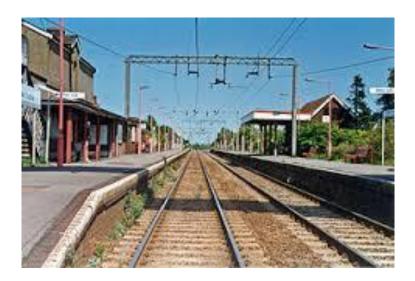
Staff injured by OLE failure (continued)

- On the adjacent lines, an OLE team using three MEWPs were carrying out preparation for the de-wiring and removal of the existing OLE wiring systems.
- Whilst preparations were underway it appears that the existing OLE dropper suffered a failure causing the OLE to fall downward.

- The existing radius of the wiring allowed the cables to straighten and move across from the Down Electric to the Up Electric causing it to swing sharply hitting two operatives working as part of the permanent way gang on the Up Electric. One of the operatives was reportedly knocked to the ground.

- When establishing exclusion zones around work, how do you ensure they are sufficient to protect all staff including those in other teams in the work vicinity?
- For OLE works how are radial forces considered when deciding the size of the exclusion zone?
- As a COSS, what action would you take as part of your assessment on the day, if the environment had changed?
