# HSQE Briefing October 2018

# Think Safe, Act Safe and Be Safe

## ***On Track Plant overturned during tandem lift***

***Ref:*** NRB 18/15

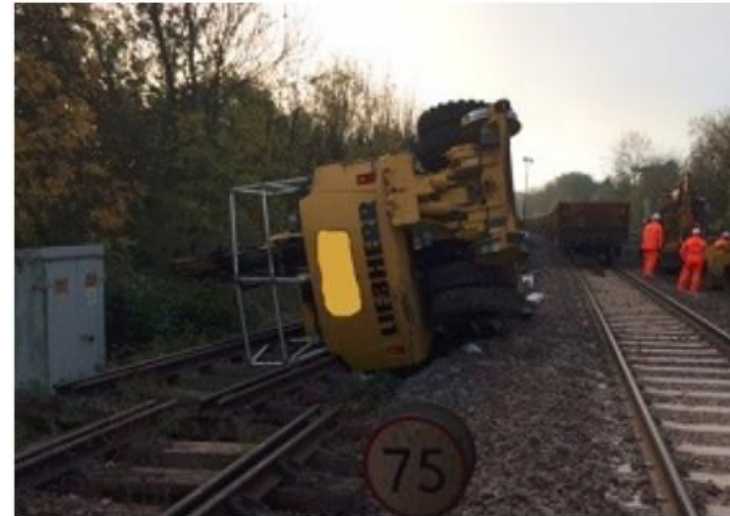
On 22 October 2018 at approximately 03:00 on an Infrastructure Projects site near Market Harborough, a Road Rail Vehicle Excavator Crane overturned whilst tandem lifting concrete sleeper track panels.

Fortunately, there were no injuries to staff resulting from the incident, though the potential for injuring staff such as the Crane Controller is clear.

- How do we confirm that Lift Planners have planned lifting activities using the correct Duty Charts or planning tools for the specific On Track Plant (OTP) being used?
- How are Lift Planners provided with and able to confirm the dimensions of the load that is to be lifted?
- Practically, how do Machine Controllers confirm that OTP is operating in the correct configuration as detailed in the Lift Plans?
- How do Machine Controllers confirm that OTP is operating in the correct mode when tandem lifting and that Rated Capacity Indicator (RCI) is switched on and functioning correctly?
- How do the Machine Controller and Plant Operations Scheme (POS) Rep confirm the OTP is the equipment identified on the Lift Plans?

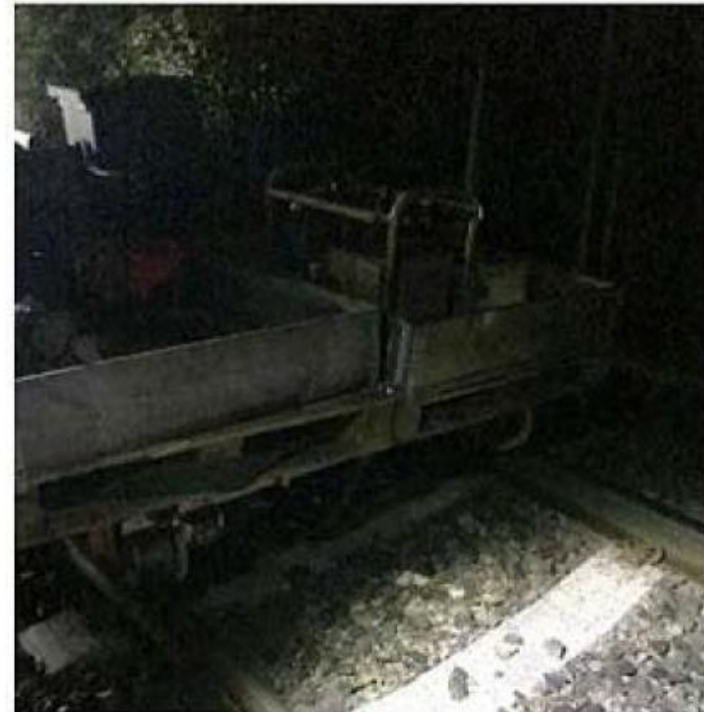
During the visit the inspector noticed that several trolleys did not have any lights visible. The teams on site attempted to rectify this issue unsuccessfully.

Another trolley was sourced to carry out the work however the brakes on this trolley were found to be defective. Further checks on the other trolleys uncovered similar conditions.

The inspector was then of the opinion that this constituted a serious and imminent risk of either runaway or collision and served a prohibition notice. The trolleys (both Type A and Type B) were immediately quarantined.

Initial findings from the investigation have shown that there was evidence a pallet on the trolley prevented the brakes from working. The pallet pressed on the spigot at the opposite end to the brake handle, holding the brakes off.

Handbook 10 of the Rule Book: 'Duties of the CoSS or SWL and person in charge when using a hand trolley' requires the person in charge of the trolley to make sure that:

- The trolley's braking system has been tested and is in good order.
  - A red flag or red light is displayed on the trolley – the flag or light must be visible from both directions.
  - Users should also check that the trolley has an in date service record and brake test.
- Any defects with the trolley should be reported and if they could affect safe use, it must be quarantined until rectified.
  - Trolleys must be loaded correctly to avoid any inadvertent disabling of the braking system.
  - A competent operator with the Sentinel competence PTMP16 must check the loading and braking every time the load is changed.
  - Planning and use of hand trolleys is covered in the Infrastructure Plant Manual NR/L2/RMVP/0200 Module P514 Hand Controlled Trolleys.

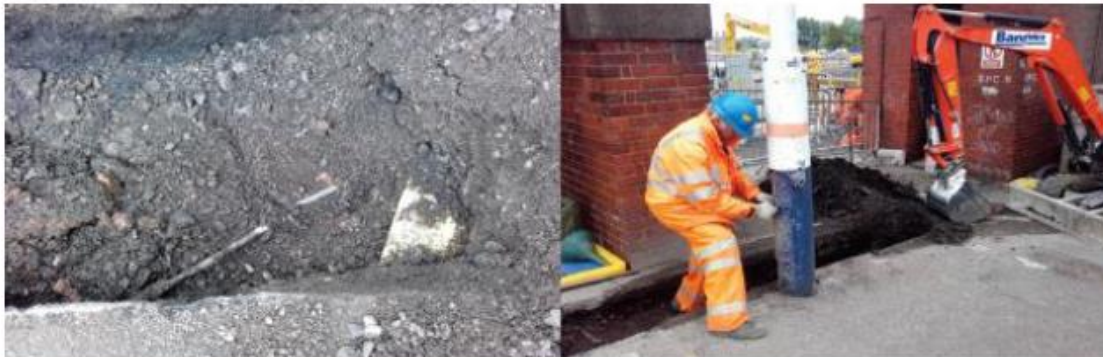
On Saturday 18 August a trench was being excavated on Platform 2 at Spondon Station. The trench would eventually carry 2No. 100mm twin wall ducts / cables for the platform lighting and public address system. As the trench excavation was nearing completion an underground cable was severed that carried power from a nearby lighting column to a bulk head light at the entrance to the station.

The method of excavation should have been hand dig only using insulated shovels or air picks due to there being known services in the area. A full time Mapping Services Engineer was also on site to carry out GPR Surveys and CAT Scanning and would then mark out all known services. Unfortunately the Ground Workers opted to use a small excavator that had a bucket with teeth on to remove the loose spoil from excavation and this is when the power cable was struck.

The Mapping Engineer advised after the event that the damaged cable had been difficult to trace since there were larger cables in the area that were giving off a stronger signal.

- By reviewing the photos below, what above ground features are present that might have indicated a buried cable was present? Look at the brick pier in the back ground.
- Why do you think the Experienced Mapping Engineer struggled to trace a lighting cable in the daytime?
- How do you challenge or change behavioral attitudes when it goes against approved methodologies and permits?
- In what circumstances should an excavator be used to dig within 1.2m of services?

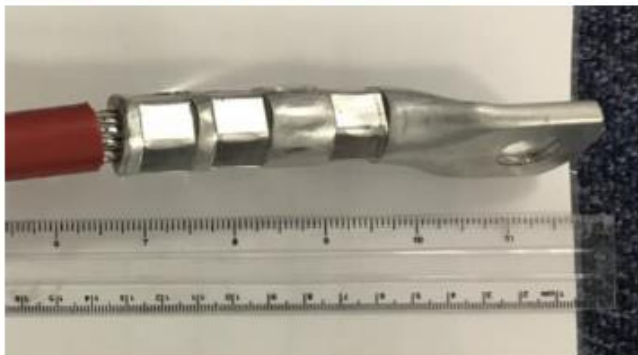
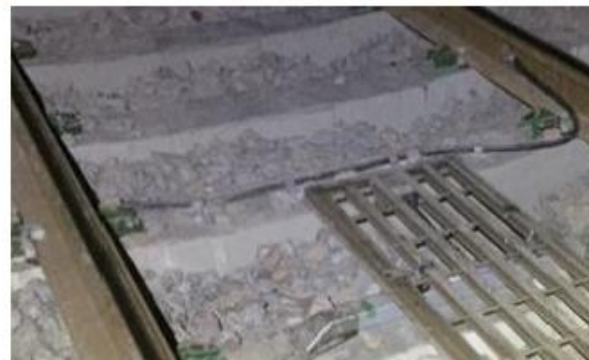
A recent accident occurred on the PARR project involving an operative being struck on the face with a crimped end of a signal bond cable which had been under tension, the loose end sprung up when it was released from its restrained position.

The operative suffered a bloody nose and damage to his inner mouth and subsequently attended Accident & Emergency to be checked over. The cable had been secured at a low level by being wedged between two steel plates and when the operative handled the cable it sprung up with force and hit him in the face.

- The next user that will be working with a disconnected cable should be considered when cables are being temporarily restrained. **No hidden traps**
- Although smaller diameter cables possess less risk there is still the potential to injure soft tissue such as eyes so appropriate eye protection should be worn at all times
- Methods of temporarily restraining the cable should be appropriate and consider the potential for slippage or other sudden movements
- Persons handling the cable should ensure that they have a firm grip of the cable at the loose end
