HSQE Briefing September 2017

Crushing Fatality

Advanced lookout struck by a train

Close call involving conductor rail short-circuit

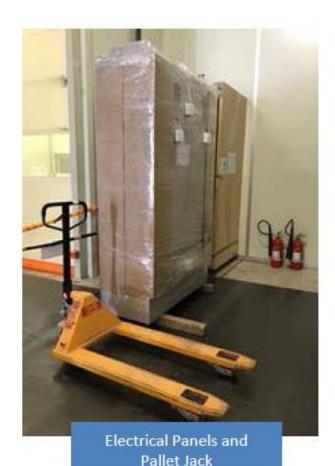
On 27 July 2017 a lift operator was crushed beneath a box of heavy electrical panels, which fell off a pallet jack. The lift operator had exited the lift to assist with the movement of the load, but as the pallet truck entered the lift it stopped suddenly, and the momentum in the load led to the panels toppling. The load had not been secured for the movement.

- Lack of recognition of the hazard.
- Electrical panels were not secured on the pallet jack.
- The pallet truck was not the right equipment for moving such high centre of gravity loads.
- Insufficient staff were available to undertake the task safely.
- Lack of task planning.

- The right equipment to be used to move loads.
- Suitable risk assessments to be in place for using lifting equipment, in particular pallet jacks.
- Pre-start briefings take place which address the use of pallet jacks.
- Pallet jacks are not overloaded, and loads must be secured.
- Manufacturer's guidance is taken into account in relation to the type of load the pallet jack is suitable for moving/lifting.

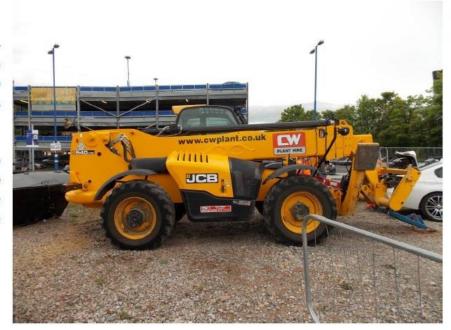
On the 30th August 2017 at Wycombe Station, an operative was seriously injured when he came into contact with a JCB tele-handler.

The IP was working with the machine operator to lay "bog-mats" in preparation for heavy vehicle access.

Whilst positioning a section of "bogmat", the IP became trapped at the front of the machine causing injuries to his right leg. Exact details of his injuries are not known at this stage.

- Never enter the exclusion zone unless directed to by the person in charge.
- Maintain eye contact with machine operator at all times.
- Ensure effective communications between M/C operator and others including slinger/banksman.
- Check lift plans for all activities involving lifting of plant or equipment.
- Review similar activities either current or planned to ensure all are properly planned and briefed.
