# Safety Briefing

Resourcing

March/April 2014

### **Network Rail Safety Bulletin**

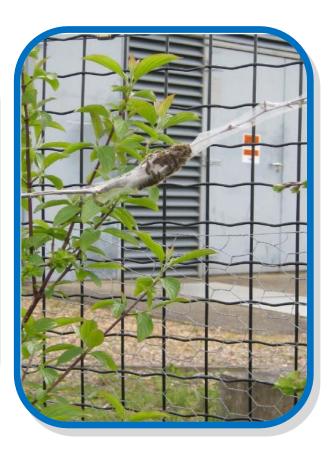
Do not approach or touch the caterpillars or the 'tent' (Image 1).

There are a number of these 'tents' and their caterpillars on the vegetation within SIMD (Image 1 – Near to SR21). Additionally, there are a large number of 'tents' on the Highways landscaped land, along Henhurst Road (on approach to SIMD). You should be aware that the 'tents' may be at locations along the Operational Railway, particularly within the landscape plots.

Contact with either the caterpillar or the 'tent' should be avoided but if you do come into contact minor skin irritations should be washed immediately with hot soapy water and calamine lotion applied, if necessary. If you have serious, persistent symptoms, for example if one of the hairs goes into your eyes or are inhaled, you should consult a doctor.
