Safety Briefing

May 2014

Resourcing
Solutions

Welcome to Resourcing Solutions's May 2014 safety briefing

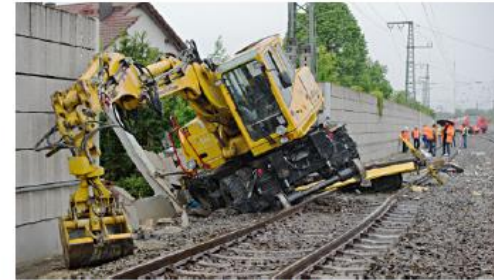
On 7th May 2014, just outside Munich, Germany, a train collided with a Road-Rail Vehicle injuring four construction workers and the train's driver.

The digger was being used for work on an opposite track to the train, but it appeared to pivot, hitting the driver's carriage. The force of the impact smashed the digger into a wall and flying debris damaged three neighbouring houses.

The driver was seriously injured and flown by helicopter to hospital.

The four construction workers suffered minor injuries.

- Attitude – Always make sure that you have been briefed, understand and adhere to all the ALO controls that are in place on your worksite.
- Influence – Ensure that those around you understand and adhere to all control measures that are in place. Challenge through questioning.
- Management – Ensure that sufficient ALO control measures are in place and briefed out to all staff prior to commencement of works and throughout their duration.
