Infrastructure Projects Signalling - Shared Learning

18/02: March 2018 – December 2018

This Shared Learning document details key issues and incidents that have occurred on Signalling Projects between March 2018 and December 2018 and provides the key learning points associated with them.

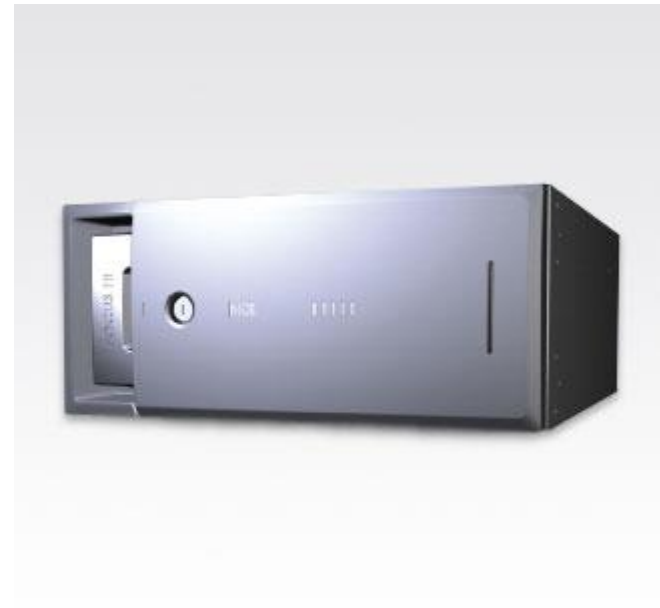
Investigation found that there was confusion regarding who was responsible for the VR configuration and test, and the Entry Into Service plan did not have sufficient detail on the VR.

Responsibility demarcations should be clearly documented and briefed to all project staff. Where tests are being performed by a third party they shall be defined and included within testing documentation.
