# Safety Briefing

July/August 2014

Resourcing  
Solutions

## Welcome to Resourcing Solutions's July/August 2014 safety briefing

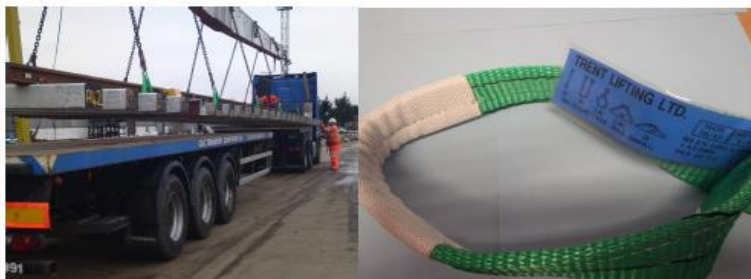
Single use lifting straps are used to load S&C modular panels. These straps are generally left attached following loading and can sustain damage in transit. Some may reach the receiving party in what is perceived to be "good condition" leading to the possibility of being re-used. This is not permissible; these straps are intended for single use only.

- Under no circumstances should single use straps be reused.
- Single use straps will be marked in black ink with the wording "Single Use Only" by Vossloh.
- Once loading is complete the straps must be gathered up and made safe by cutting through the eye ends.
- If a load reaches the receiving party with lifting eyes intact, these must be cut through and disposed of in the appropriate manner.

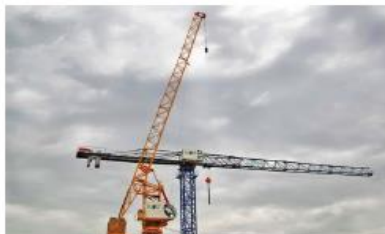
Following the collapse in high winds of a JOST JTL158.6 luffer crane in Croydon, London on 25 January, 2014, JOST Cranes (JOST) has undertaken an investigation to determine the cause of the failure. Three other failures of JOST crane jibs had been reported in the twelve months previous.

The investigation determined that the operator had failed to leave the slewing brake off when out of service as described in the JOST Operating Instructions. This resulted in wind loading that exceeded the capacity of the jib, causing collapse of the structure.

HSE have also scrutinised the design of these cranes and have determined that although the designs are compliant to all applicable standards, the strength of the mast is "marginal" when compared to anticipated wind loading in the design condition, and that there is reasonable scope to make these cranes safer by design in accordance with the best practice hierarchy for risk reduction.

JOST have proposed some improvements to their crane design which will enhance the ability of the cranes to resist high wind loads. These modifications are detailed in the document 'Improvements on JTL Cranes' v4, which can be obtained by emailing Luke Tandy at [luke.tandy@networkrail.co.uk](mailto:luke.tandy@networkrail.co.uk).

All JOST JTL 108, JTL 158 and JTL 208 Tower Cranes are prohibited from being used either directly by Network Rail or by any Principal Contractors or sub-contractors for use on, or within the collapse radius of, Network Rail managed Infrastructure or on Network Rail projects until the modifications detailed in the above document have been implemented.
