**Resourcing
Solutions**
engaging people

HSQE Briefing
September 2019

Continuing near misses with track workers

On-Track Machine Runaway at Taunton Operating Base (OB)

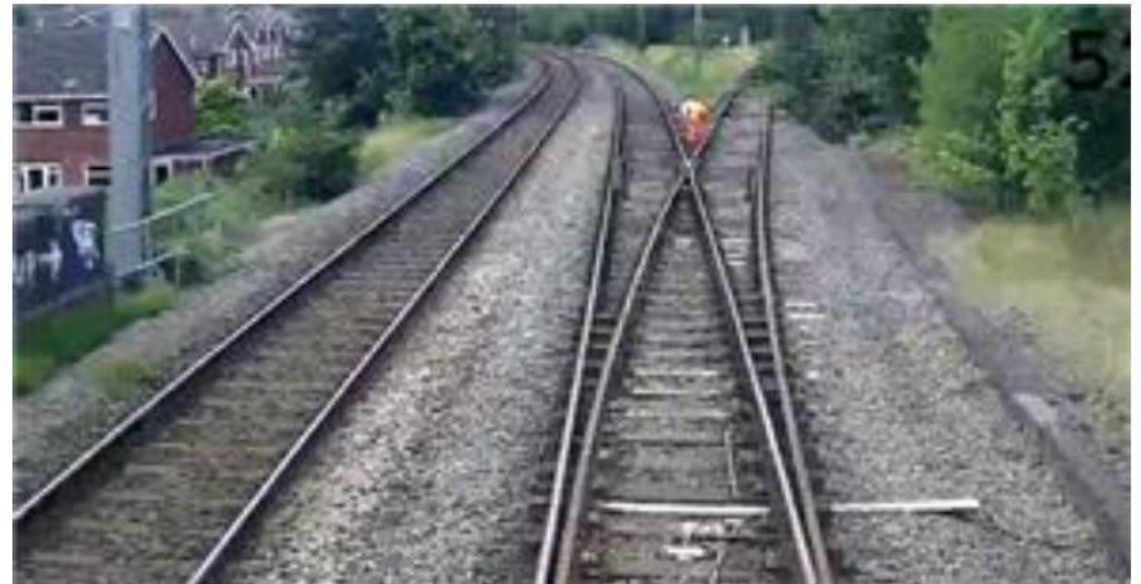
On 15th August in Lichfield, Staffordshire, a train driver observed a person wearing orange PPE, crouching in the four foot. The train was travelling at 20mph (linespeed). The driver of the train sounded his horn and the individual moved clear of the line.

The member of staff in the four foot was a patroller and was alone on track at the time of the near miss. The patroller had been part of a larger group of five who had just completed a patrol using planned protection. The patroller returned to the track on his own following the report of a fault

- The first patrol was completed under planned protection.
- A fault had been identified which caused patroller to go back to rectify.
- There was no protection in place for the return to the track.
- The patroller returned to the track alone.
- The patroller was working the 14th day of continual duty.

- Always be sure the required plans and permits are in place before you start a job or go on or near the line.
- What methods do you personally use to manage fatigue?
- Where would you raise concerns about excessive working hours?
- Every person in our organisation must ask, in my role;
 - "How am I responsible for my own and others' safety'?"
 - "How do I influence others (positively and/or negatively) in relation to work demands?"
 - "Am I prepared to be open, honest and, if necessary, intervene to ensure my own or others' safety?"
 - "How will my team's safety conversations make it clear that no person working for or on behalf of Network Rail is permitted to work without a suitable safe system of work?"

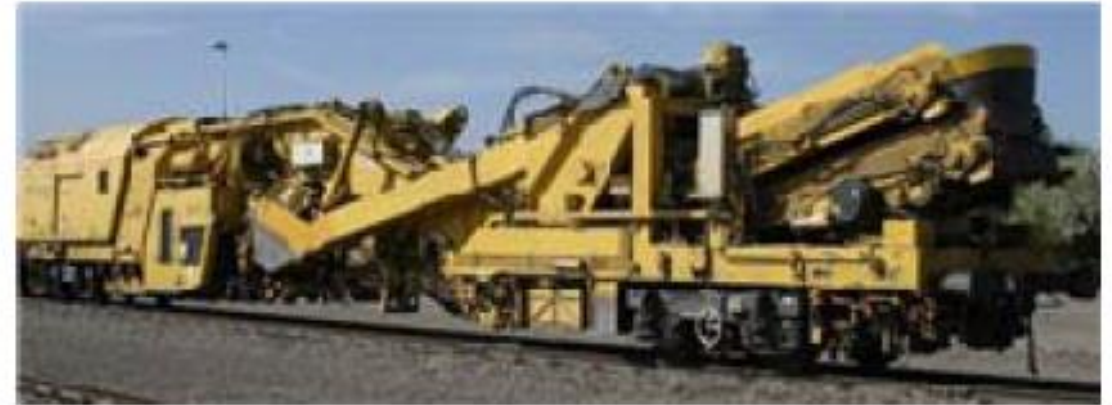
On Thursday 29 August, a Network Rail On-Track-Machine (OTM) ran away from a connecting locomotive at Taunton Operating Base (OB), following a routine maintenance event.

In preparation for a shunting movement, a member of staff checked that the handbrake was applied and removed the scotches holding the OTM stationary for maintenance. As a locomotive buffered up to the OTM, the OTM began to run away. Fortunately, the OTM was stopped when a member of staff intervened by placing a scotch under a wheel of the OTM which prevented the OTM running away down the yard. No one was harmed.

Early indications show that the handbrake had been applied prior to the locomotive buffering up to the OTM. However, shunting staff were unaware that a defective brake cable had left the handbrake incapable of holding the OTM stationary.

- The safe systems of work for train maintenance and shunting activities that are designed to prevent unintended vehicle movements in sidings and depots. Are they adequate and are they applied correctly?
- The importance of adequate planned preventative maintenance and maintenance instruction to identify and repair rail vehicle defects.
- The management of vehicles with brake defects in sidings and depots. How and when should the brakes be checked? If the defect can not be rectified immediately how is this hazard made clear to other staff who may subsequently rely on the brakes to hold the vehicle in a stationary position?

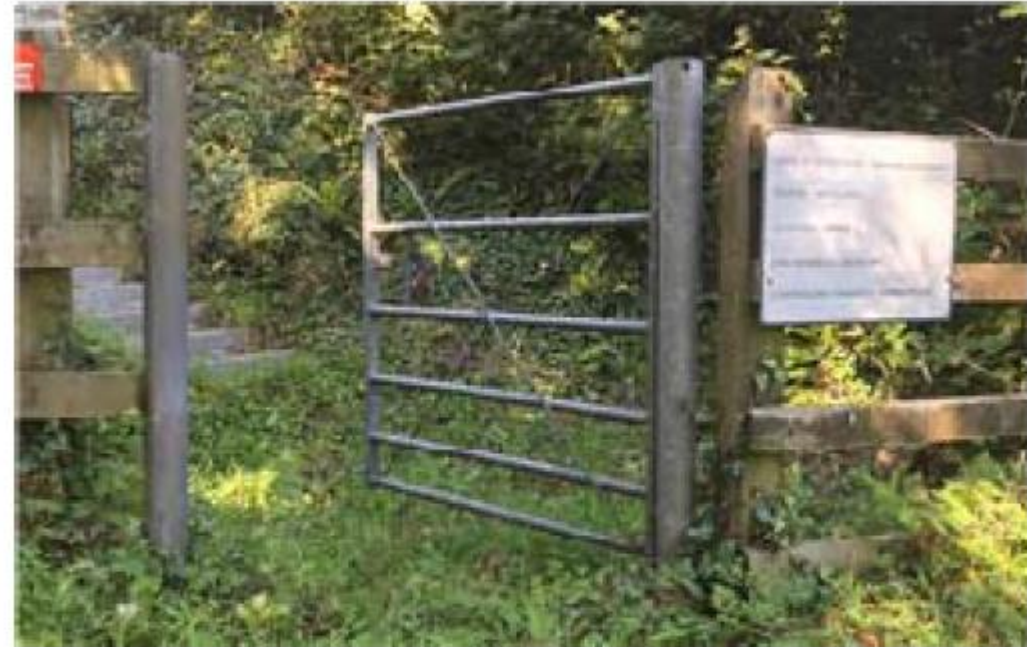
On the 15th September an access gate was left unlocked between Topsham and Exton on the Exmouth branch line following track renewal work in the area. When staff arrived to secure the gate, children were found on the line having accessed the railway via this gate.

Insecure access points allow trespassers to access the infrastructure. This poses serious safety and security risks and provides an opportunity for crime and malicious acts to occur.

To ensure safe access and egress to the Railway infrastructure apply standard NR/L3/TRK/002/D15, which states that access points should be routinely inspected, checking that they are secured and if not notifying fault control.

Authorised access points should be secured when not in use.
